**To:** Members of the Pamet Harbor Commission  
**From:** Jarrod J. Cabral, Department of Public Works Director  
**Date:** January 19, 2023  
**Subject:** DPW Update

# **Mill Pond Salt Marsh Restoration Alternatives Assessment Technical Memorandum**

**Town of Truro**  
Truro, MA

June 2022

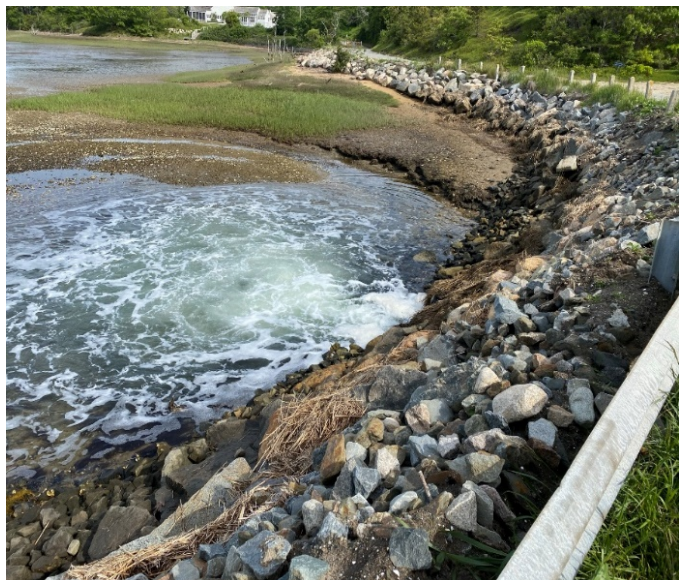
Figure 2 — Downstream Culvert Outlet and Stone Armor Slope Protection (Facing North)

The downstream face of the embankment is currently in poor condition as exhibited by displaced slope protection and debris build up around the culvert discharge point. The Town of Truro completes maintenance on the embankment annually to restore displaced riprap and repair areas of erosion. In addition, a scour hole is positioned at the discharge area at the beginning of the Mill Pond Channel.

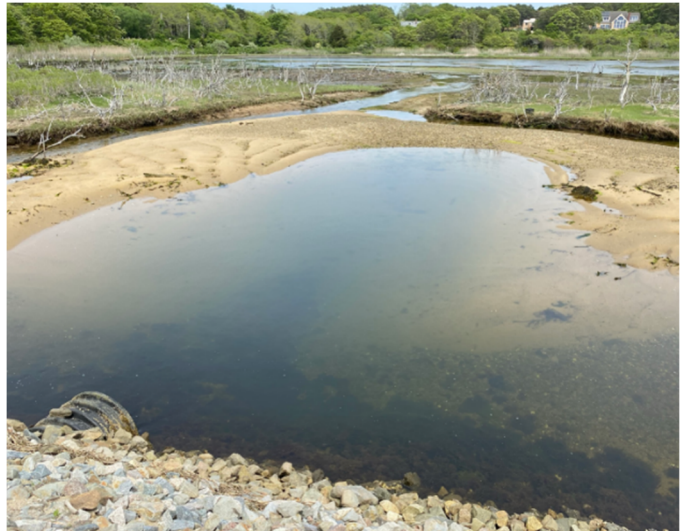
The upstream end of the CPP projects from the earthen causeway supporting MPR, which is partially covered by stone armor protection over and adjacent to the culvert. Indications of a tidal restriction near the culvert's end include a scour hole with an intertidal island formed by shoaled

Figure 3 — Upstream Culvert Outlet, Scour hole and Shoaled Sediment (facing east)

sediment, a significant tidal lag and muting, poor drainage during inland precipitation events, and bank erosion adjacent to the culvert.

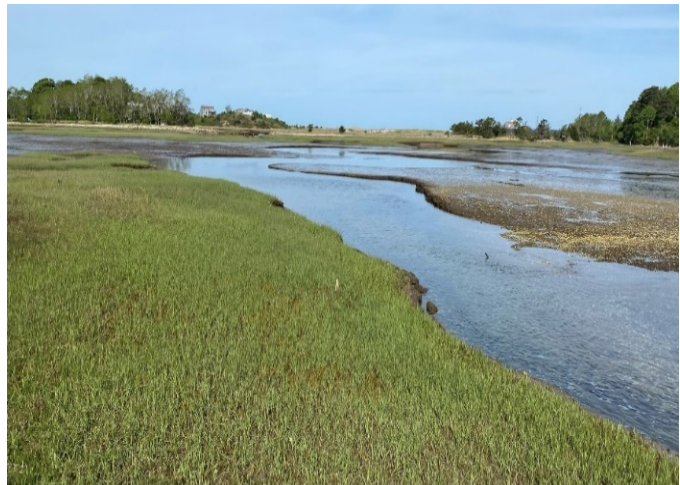
Figure 4 — Downstream Tidal Channel and Abutting Salt Marsh (facing west)

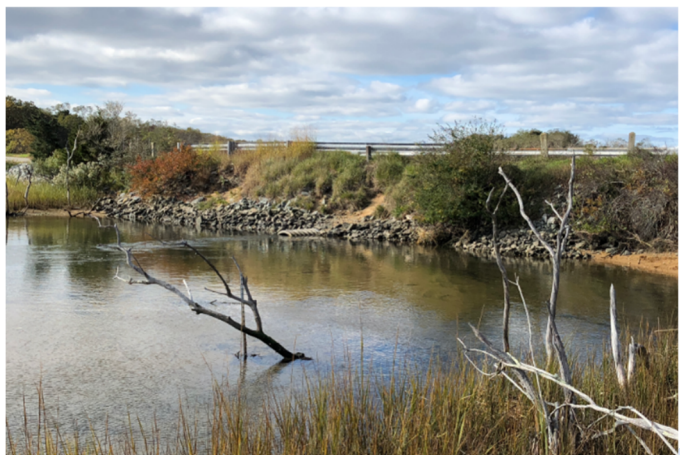
Figure 5 — Upstream Culvert Outlet and Stone Armor Slope Protection (facing south)

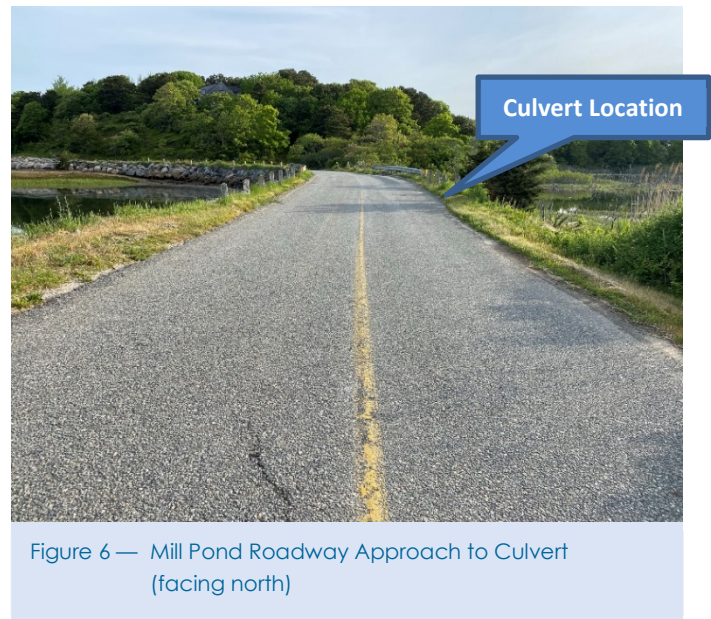
Embankment slopes behind the guardrails exhibit signs of erosion and steepening, providing inadequate lateral support to the guardrail system, as indicated by leaning posts supporting the horizontal rail on the roadway's southbound (western) travel lane. Concrete posts are positioned beyond the ends of the metal beam guardrails in both directions at an approximate 8 foot spacing.

Survey measurements along the roadway's centerline profile on both sides of the culvert indicate low points approximately 80 feet north and 115 feet south of the culvert (0.1 feet and 0.65 feet lower, respectively, than the roadway elevation at the culvert). The roadway is pitched to the upstream (east) slope in proximity to the culvert, with a small section south of the culvert nearly flat.

Figure 6 — Mill Pond Roadway Approach to Culvert (facing north)

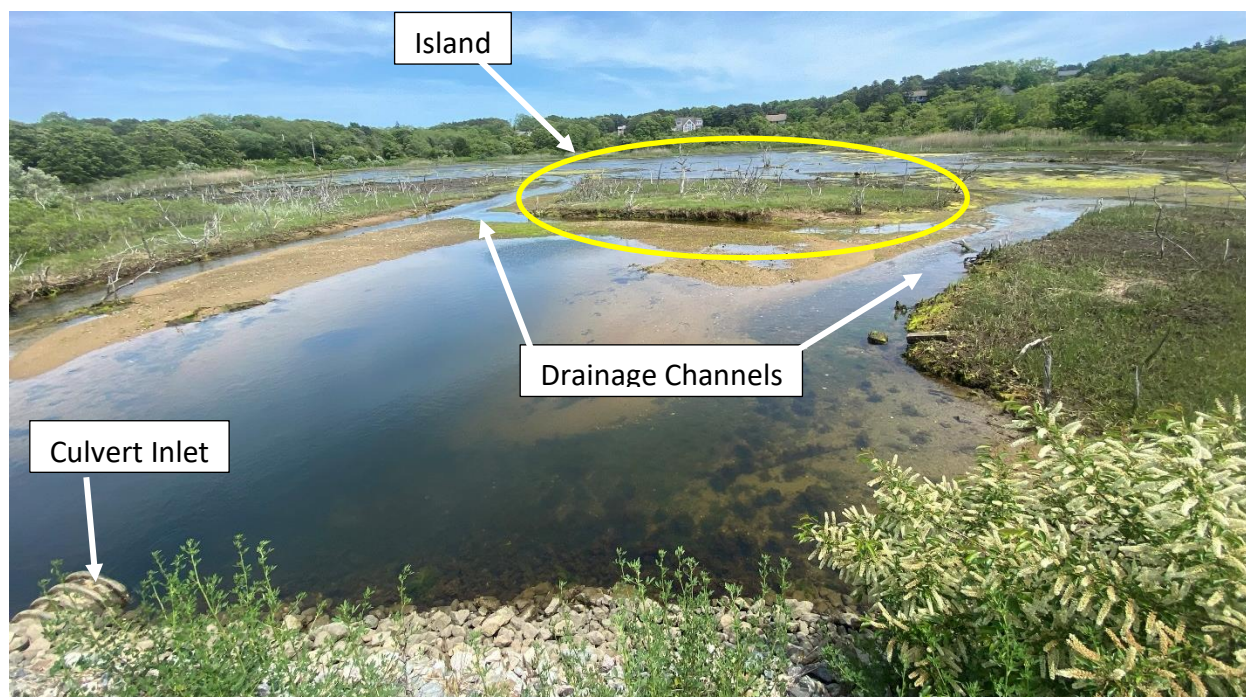
**Figure 7.** Photo of the Mill Pond culvert inlet (bottom left), the island (yellow circle) that acts as a weir, and the drainage channels around it.

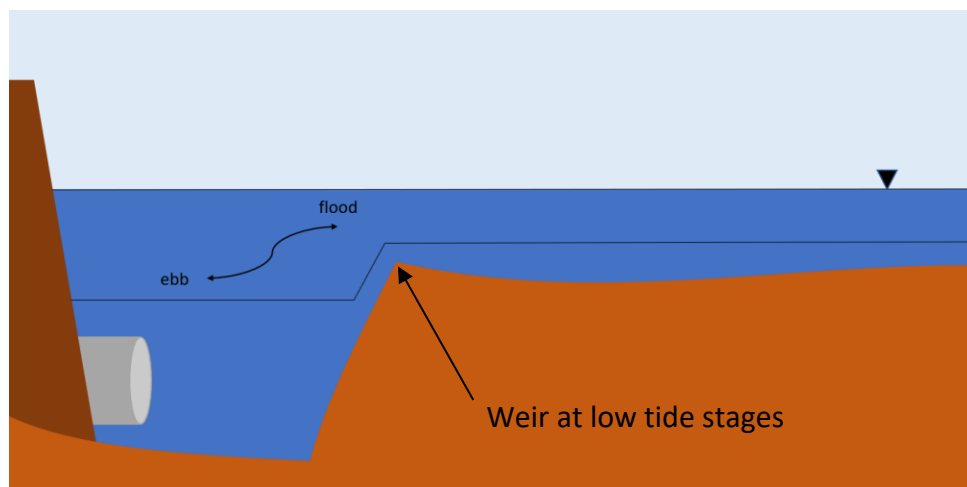
**Figure 8.** Sketch of the culvert through the embankment and into Mill Pond, the invert is at a lower elevation than the bed of the pond, which causes a weir effect over the island and into the scour pit that impedes full drainage. Note the graphic is not to scale.
