**Truro Historical Commission**  
**Remote Meeting Agenda**  
**Tuesday, October 1, 2024, at 5:00 pm**

**TOWN of TRURO**  
**Truro Historical Commission**  
**Truro Historical Commission (THC) Meeting Minutes**

The Town of Truro has acquired the Walsh parcel, which includes eight (8) existing wood-frame dwellings and miscellaneous outbuildings on six (6) parcels totaling 7.92 acres and two additional parcels without buildings for a total of 69.8 acres. The Town has a pressing need for additional housing for Town employees, seasonal staff, and others, and wishes to evaluate the structures and the overall site for redevelopment. This may include renovation or replacement of the houses in-place, new free-standing or clustered residential units, or some combination of both. The need for three types of housing has been identified; traditional single-family, transitional (shorter-term) housing for relocated Town employees, and group- or dormitory-style accommodation for seasonal staff. Other housing types or scenarios may be developed as our work with the Town progresses.

Prior to proceeding with full programming and conceptual design of housing alternatives, the Town has asked Weston

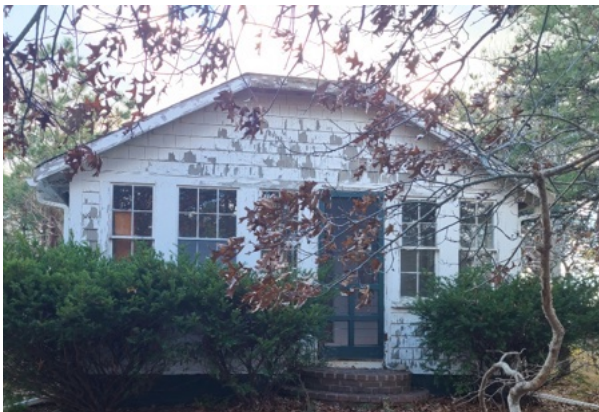
Front addition. Brick mortar steps, and peeling paint on shingle siding and fascia, rake, door and window trim boards.

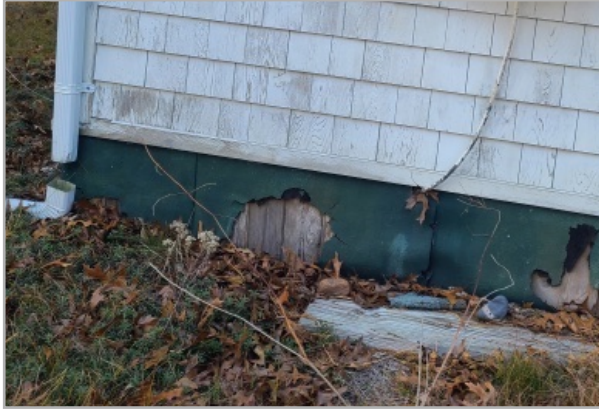
*The foundation skirt has rotted through a damaged membrane layer.*

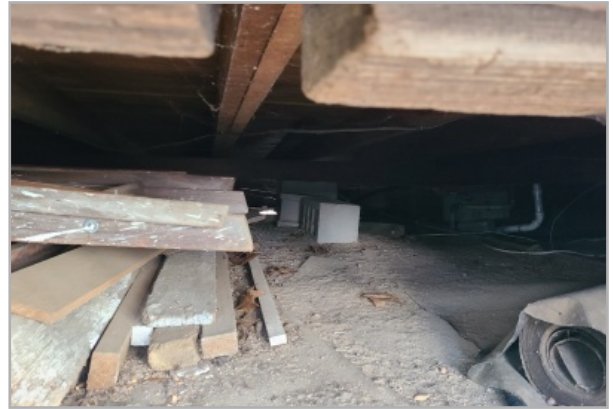
*View to crawl space showing notched 2x6 beams and 2x6 wood floor joists. The exposed underside of this and many of the other cottages creates a potential habitat for wildlife.*

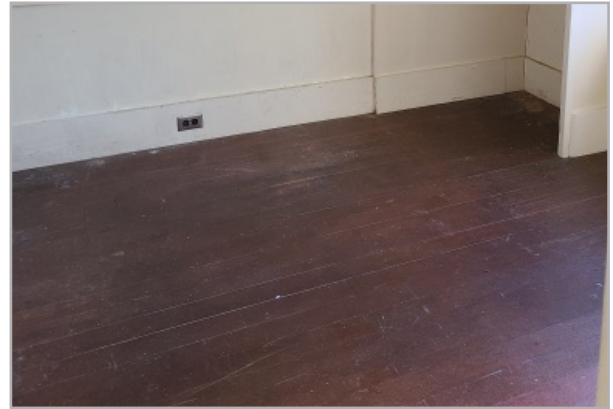
*Wood flooring in bedroom is in fair condition. Non-grounded electrical outley located in baseboard.*

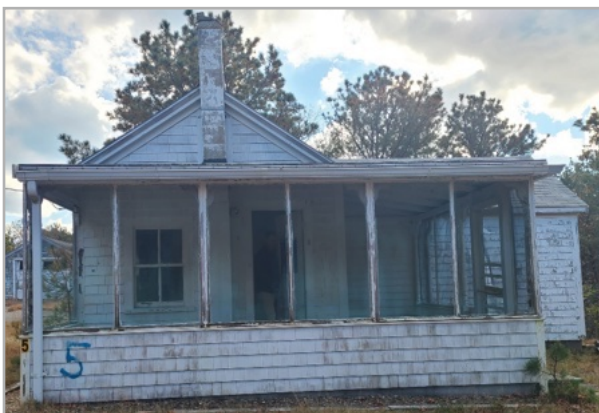
Front of cottage where a covered porch wraps around one corner. The screens and low walls are greatly weathered.

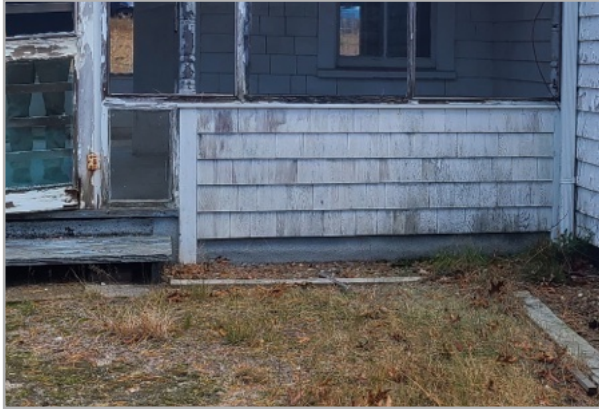
*Wooden foundation under front porch addition sitting on grade.*

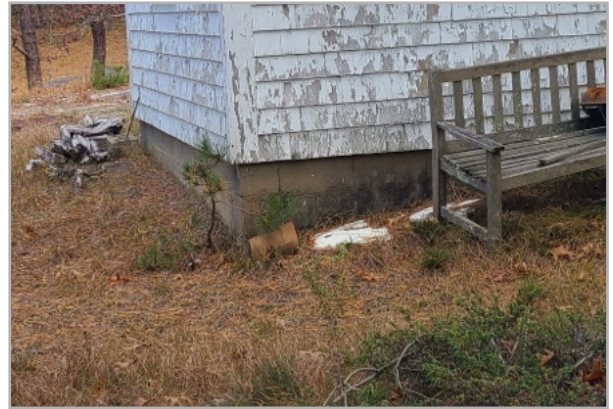
*View of CMU foundation at South West corner, vegetation is beginning to encroach and the presence of a tree sapling suggests root penetration.*

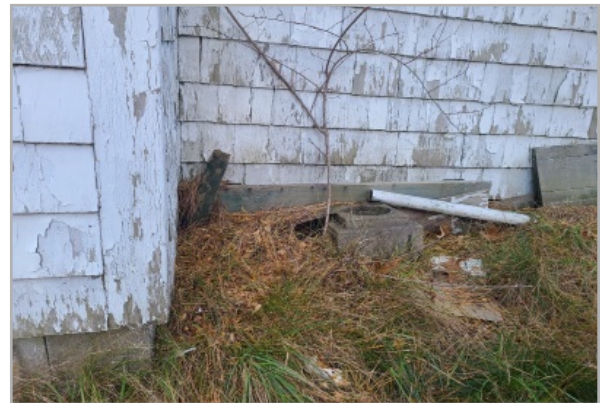
*Ground and debris built up against CMU foundation and wall cladding at Southern elevation. Voids in the wall allow animals to enter and live under the building.*

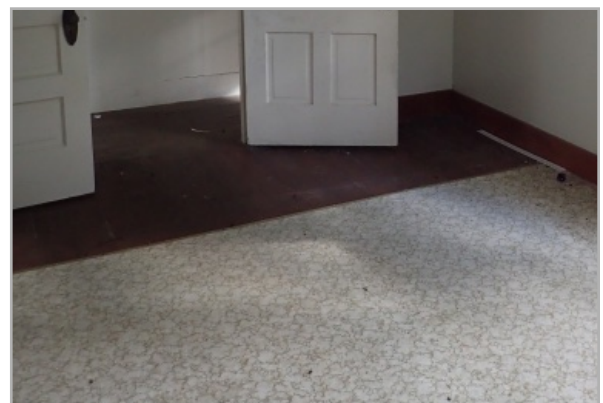
*View of room floor with two types of flooring and flush doorway threshold. The flooring is chipping and damaged in areas and must be replaced.*

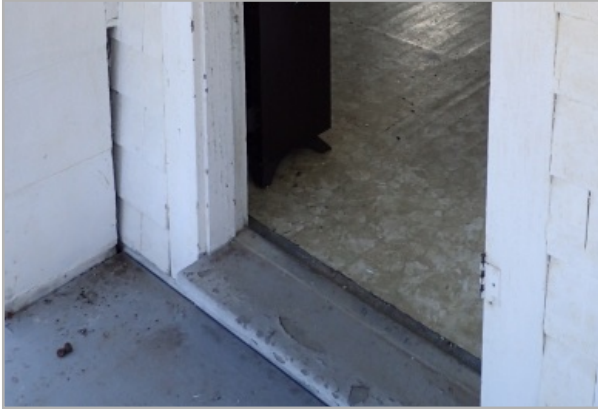
*View of exterior threshold that is greater than one inch which is non-compliant with code, and deflection in the interior sheet floor finish can be observed.*

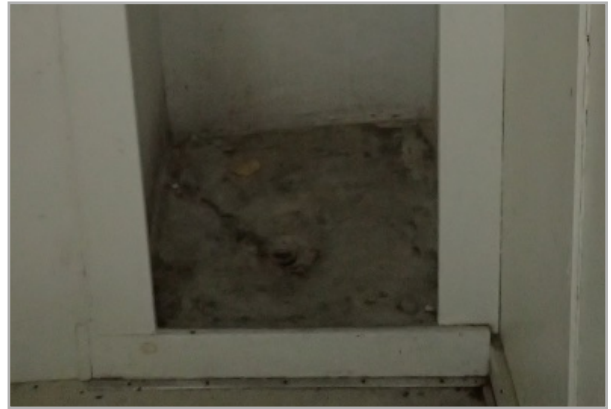
*Bathroom flooring is sheet tile, and has areas of mold growth and discoloration. The floor of the shower stall and base of wall is covered with mold and mildew growth.*

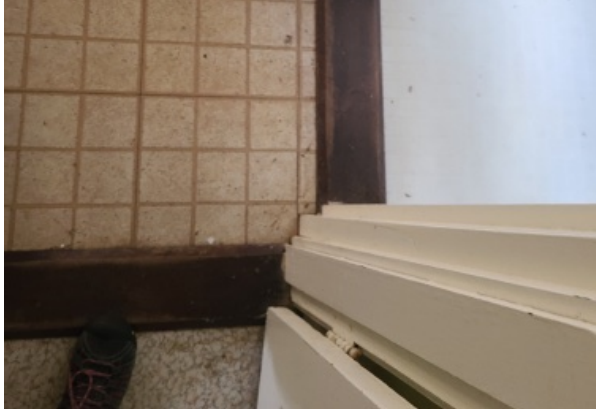
*Condition of floor finish transition. Floor plan at this location is not wheelchair accessible due to configuration of cabinets and doorways and door thresholds.*

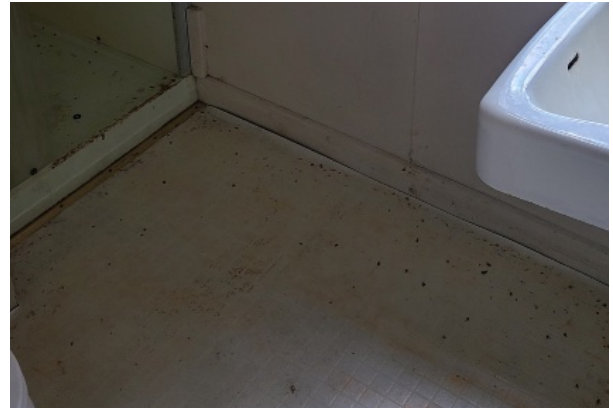
*Sheet flooring in bathroom with signs of degradation throughout and crumbling at the edges. Signs of water damage are apparent at the edge of shower stall.*

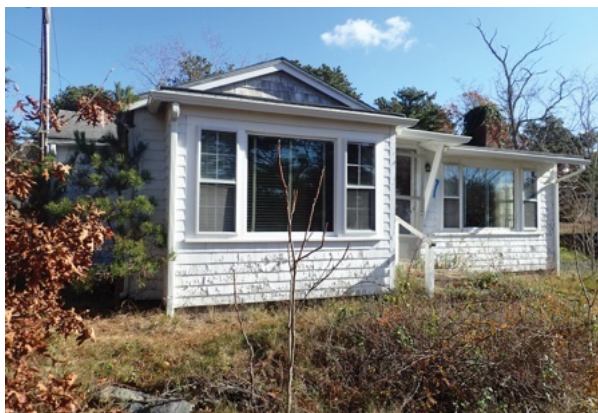
Non-compliant entry stairs at front and paint degradation.

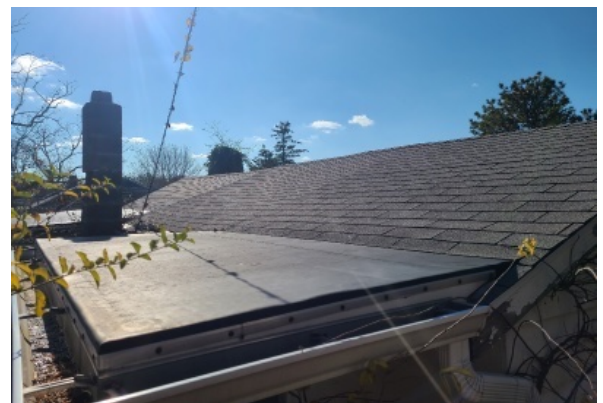
*Membrane roof condition of building additions with signs of degradation.*

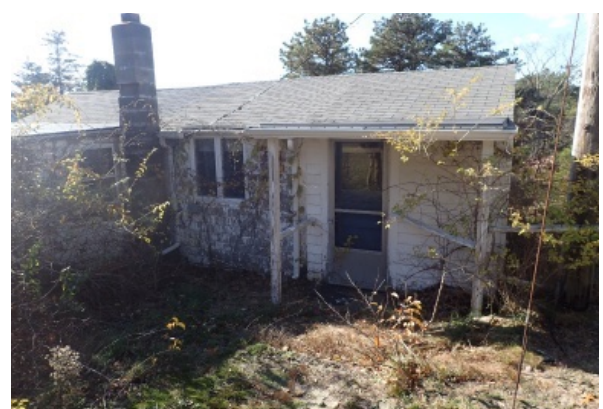
*Rear elevation of the building where vegetation has penetrated the exterior chimney and into the building interior at open penetrations. Roof edge areas unprotected by a gutter lack paint and shows signs of decay.*

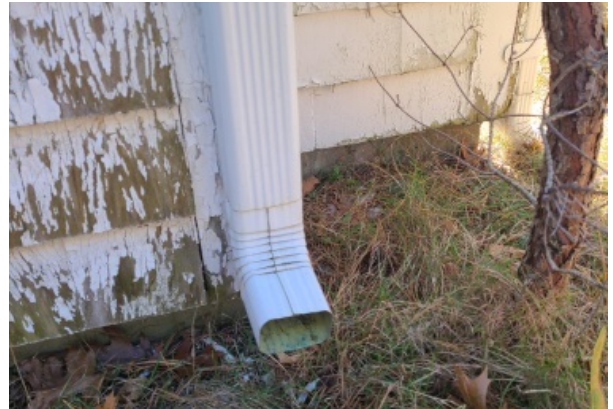
*View of the base condition of a downspout where the last length of aluminum is missing. The water run off is insufficiently removed from the building footprint.*

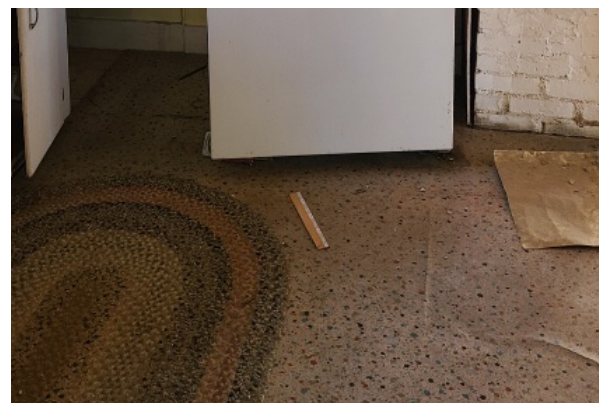
*Sheet flooring that is badly worn with visibly evident floor deflection throughout.*

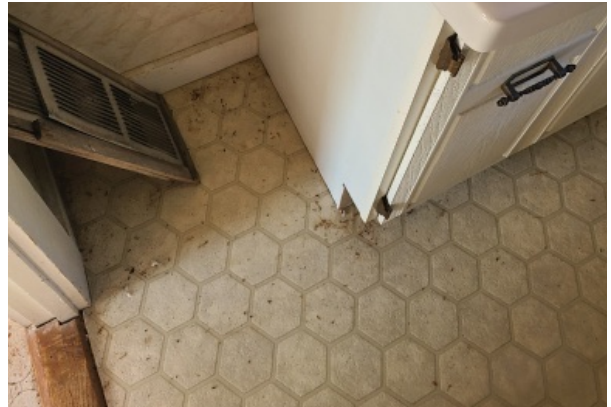
*Sheet flooring that is degrading and crumbling at the edges.*

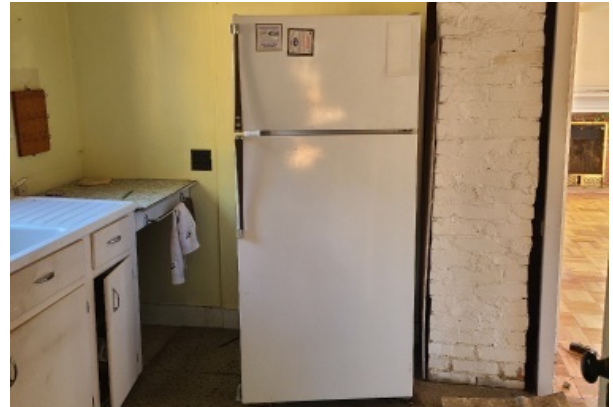
*Refrigerator that is outdated and needs replacing. Beside it can be seen what seems to be an old chimney that has been abandoned.*

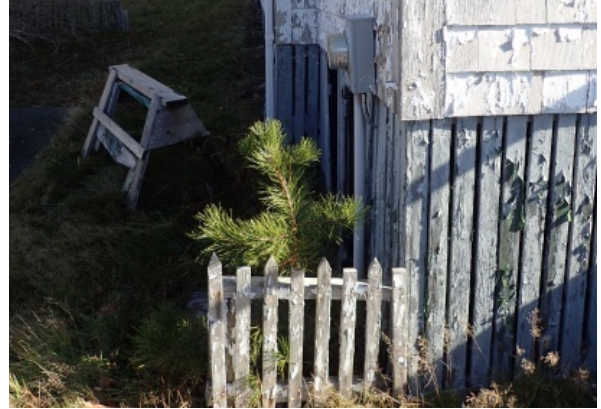
View of the foundation enclosure at the front of the building where the grade is the lowest. The boards of the enclosure are rotting and two layers of paint can be seen peeling.

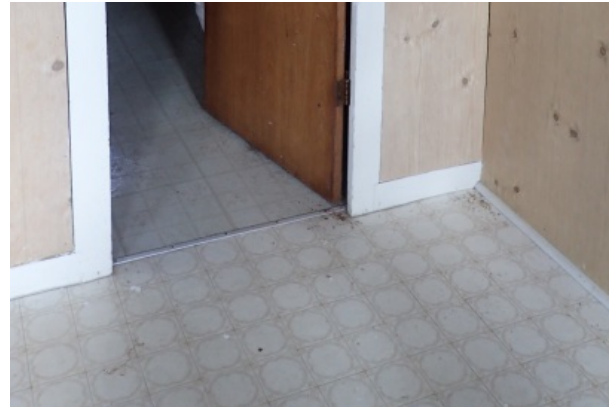
*Sheet flooring with signs of degradation throughout and crumbling at the edges.*

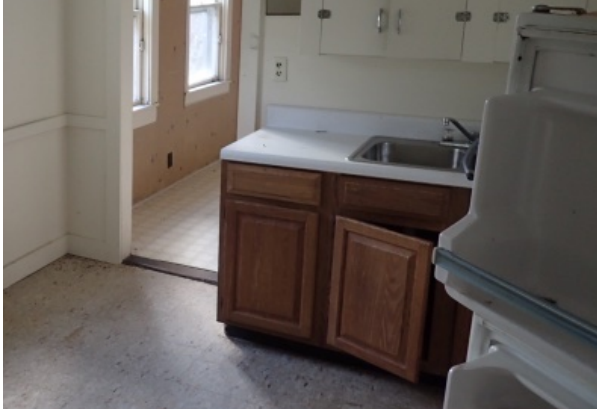
*Refrigerator and in counter double sink are present. The refrigerator has signs of mold, and must be replaced.*

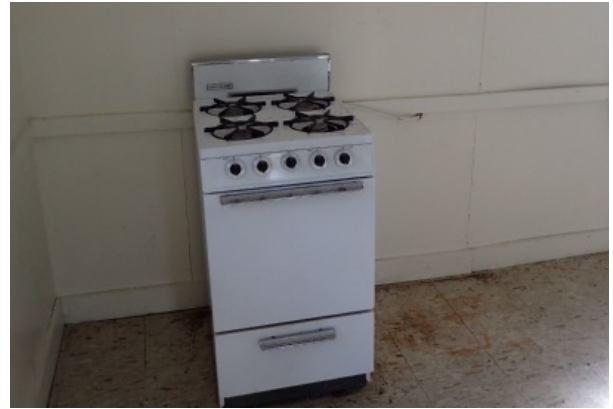
*Stove/oven fixture with exposed connection into the wall. Fixture is outdated and needs replacing.*

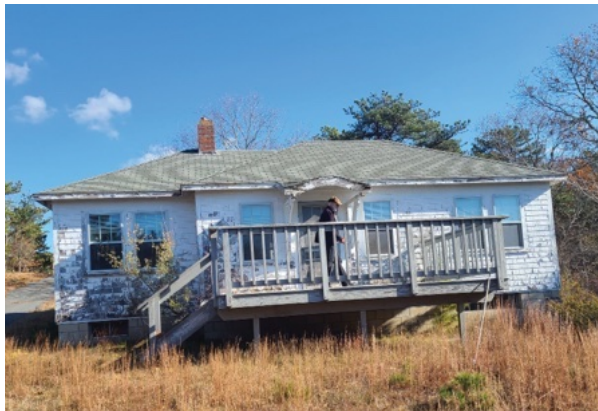
Front view of cottage, CMU foundation has two window penetrations just above grade. The paint is peeling throughout.

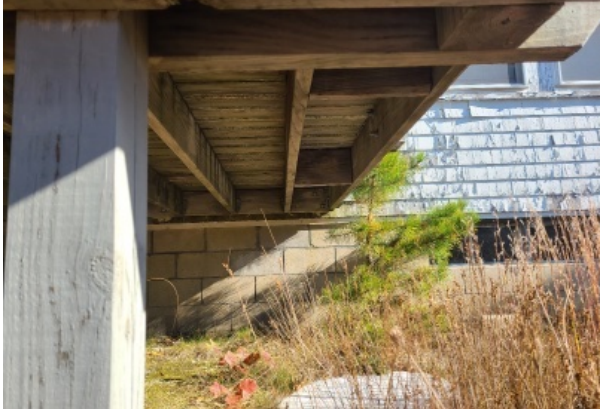
*Deck addition framing supported by the CMU foundation at one side and piers at the other.*

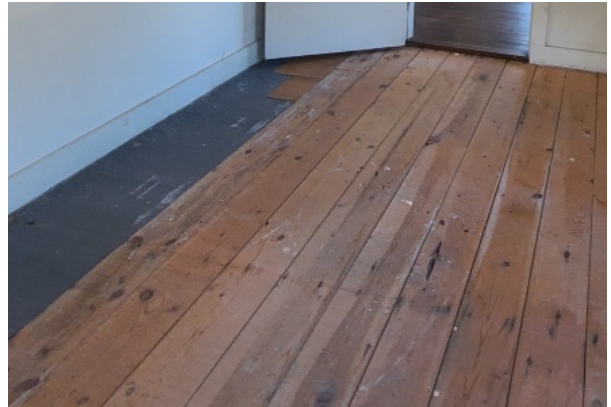
Buckled wood flooring in one of the bedrooms due to water damage.

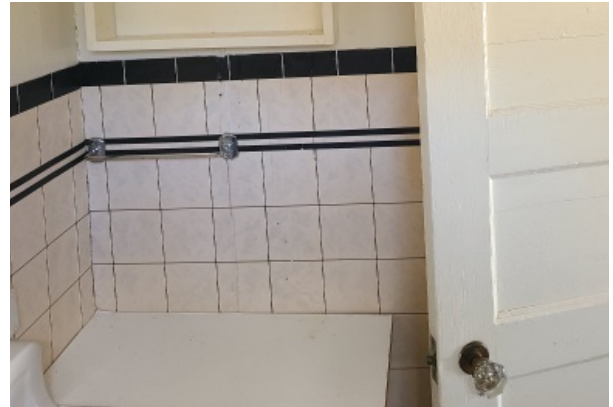
*Tile wall finish in half bathroom, terminating in a tile bull nose and has painted plaster above.*

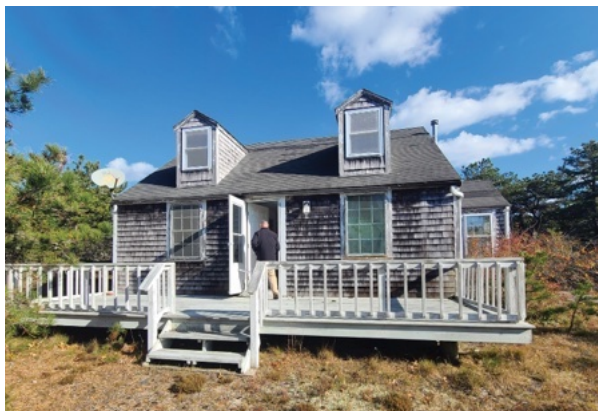
View of front of building and porch addition.

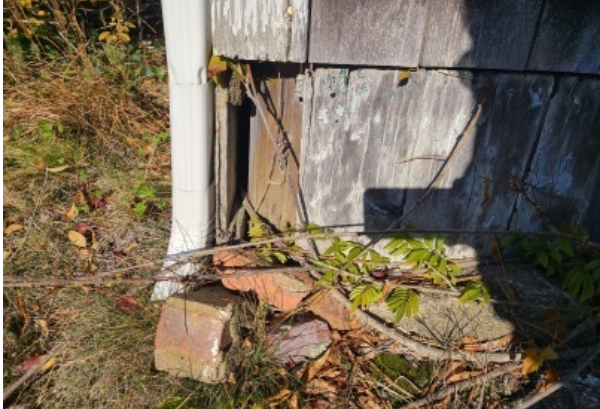
*View of foundation pier, wood siding, wood foundation skirt, and brick supports. Foundation is insufficient for this building, and was not intended to support two levels.*

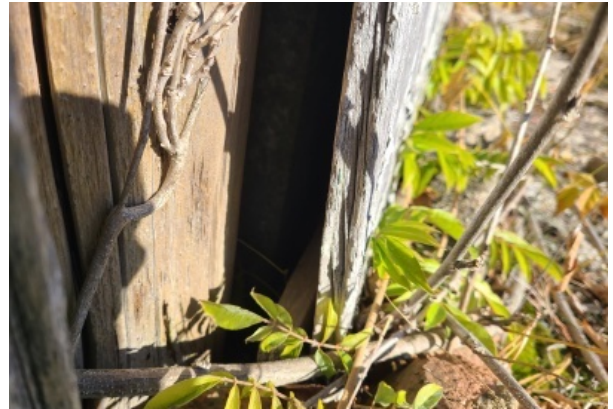
*View of foundation pier exposed at one corner.*

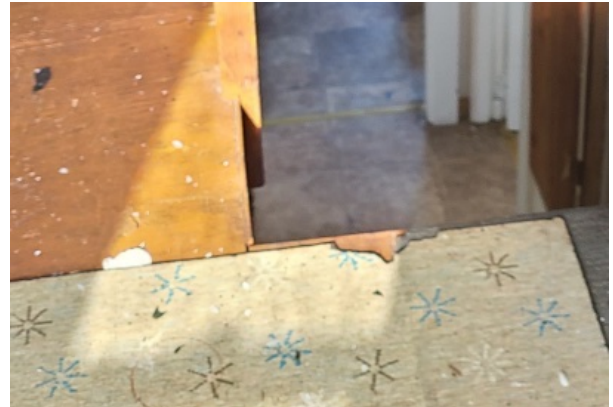
*Sheet flooring and board flooring at second level, crumbling and failing from age.*

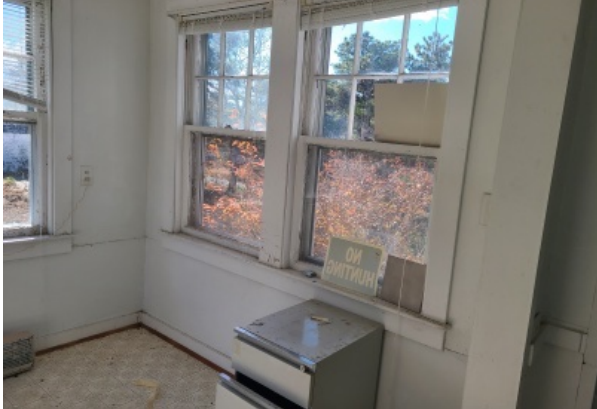
*Kitchen addition windows, single paned and damaged bug netting.*

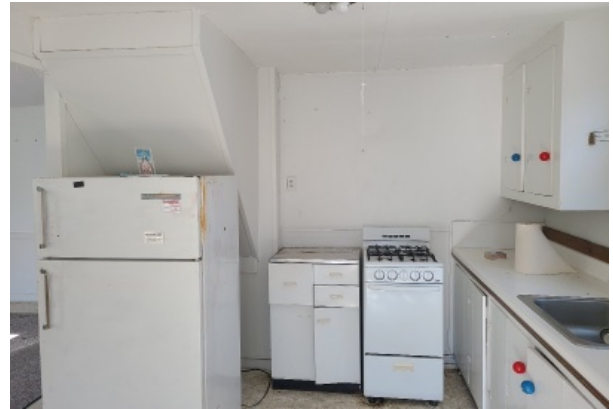
*Kitchen with refrigerator, stove/oven, and in counter sink. Both the stove/oven and refrigerator are outdated and need replacing.*

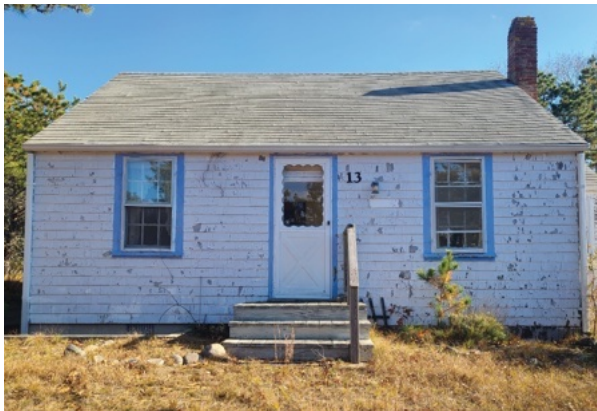
Front elevation of the building, concrete steps with insufficient railing, and original windows that need replacing.

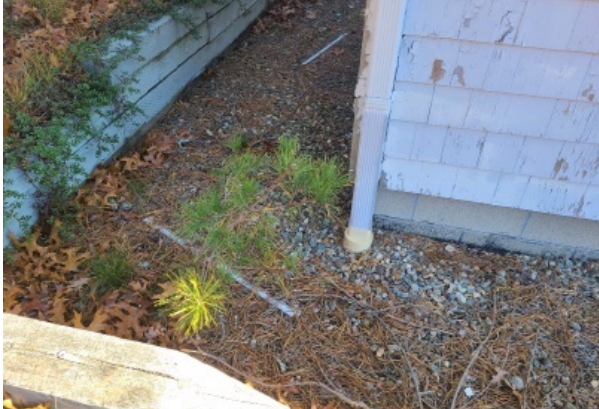
*Wood retaining wall set back from building foundation.*

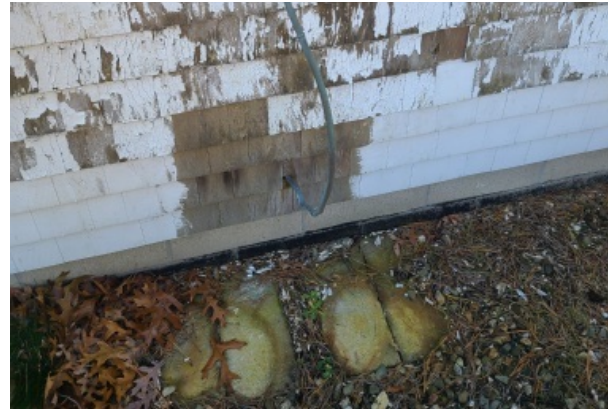
*CMU perimeter foundation with grade build up, and insufficient water mitigation.*

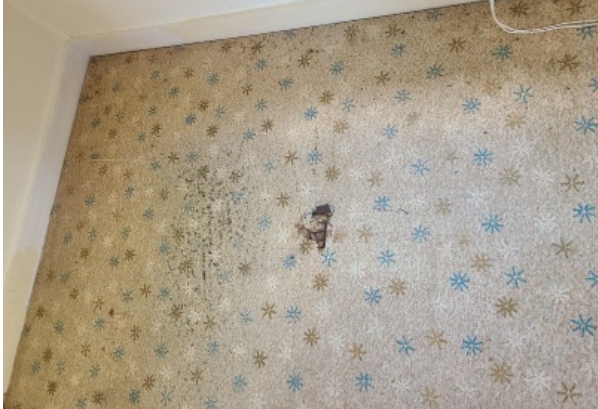
Sheet flooring, worn down to the floor sheathing in areas and crumbling at the edges.

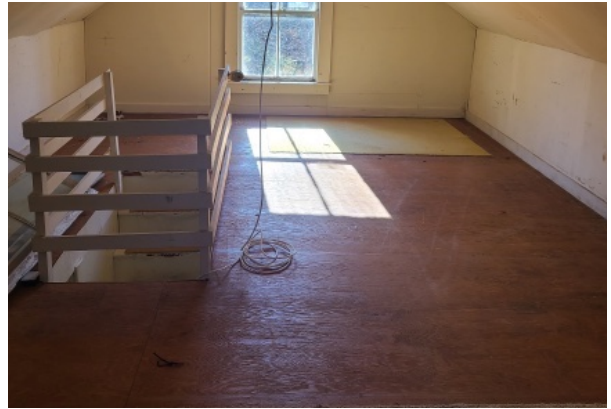
Second level flooring is exposed wood boards.

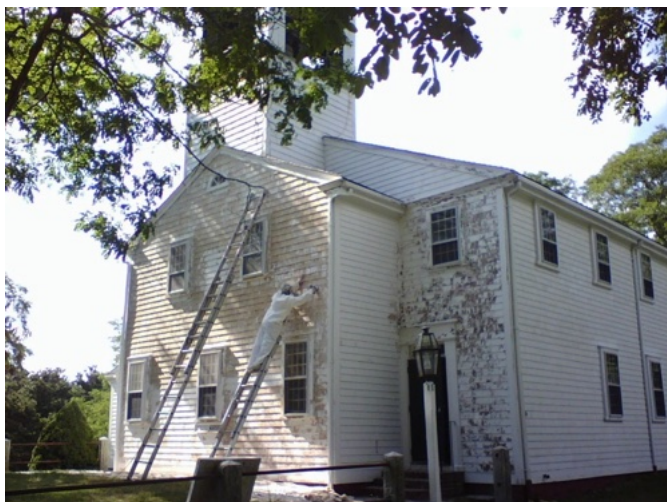
Unfortunately, when we went to repaint the South façade, it was determined that the majority of the shingles were rotted and needed to be replaced. Supply chain inflated costs delayed the project. Portions of the tower and areas that do not need replacing shingles and can just be painted will be considered normal maintenance and will not be included in this funding request, except as a possible re-shingling contingency item, that if not needed (and not billed) will be available for funding other projects.

*Repainting the South façade, 2012*
