## Welded Storage Cabinet - 36 x 24 x 74"

Weston & Sampson Engineers, Inc. (Weston & Sampson) is pleased to submit our Geotechnical Engineering Report for the referenced project. This report presents descriptions and summaries of our services, encountered subsurface conditions, and geotechnical considerations and recommendations for design and construction of the proposed project.

**FIGURE 1**  
**LOCUS MAP**  
**TRURO DPW**  
**17 TOWN HALL ROAD**  
**TRURO, MA**  
**BARNSTABLE COUNTY**

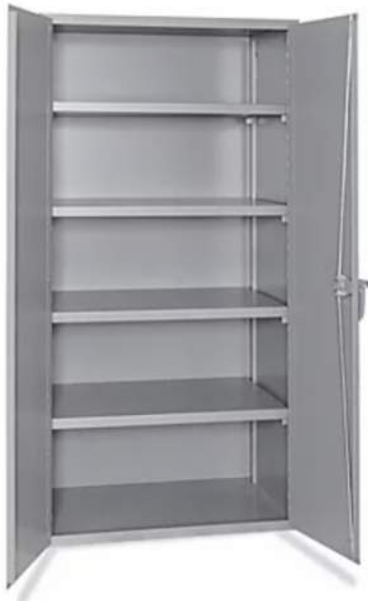
Strength and security for storing your heavy tools and equipment.

- 14-gauge steel with durable powder-coat finish.
- Padlockable handle with three-point locking system.
- Reinforced doors open on full-height hinges.
- Shelves adjust in 2 1/2" increments.

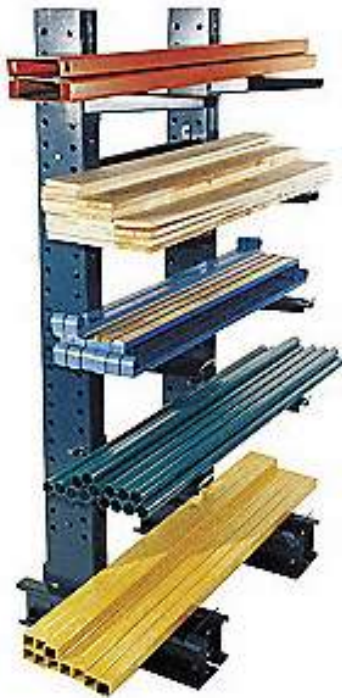
Heavy-duty pin-lock cantilever racks hold heavier materials than medium-duty and light-duty cantilever racks, such as heavy bar stock, tube stock, and sheet material. Items can be placed onto or taken off of the racks with a lift truck or forklift. The racks consist of vertical uprights and arms, and they do not require special tools or bolts to assemble. The arms attach to the uprights with a locking pin that holds them securely in place, and the height of the arms can be adjusted on the uprights.

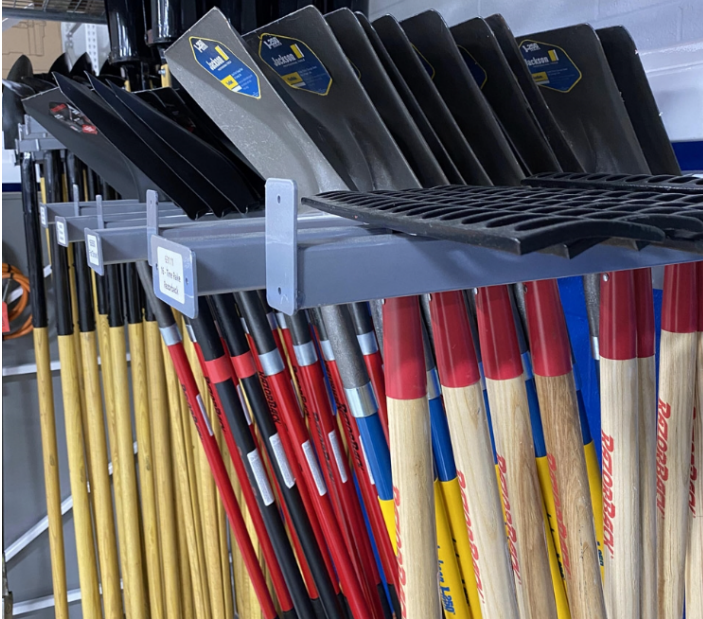
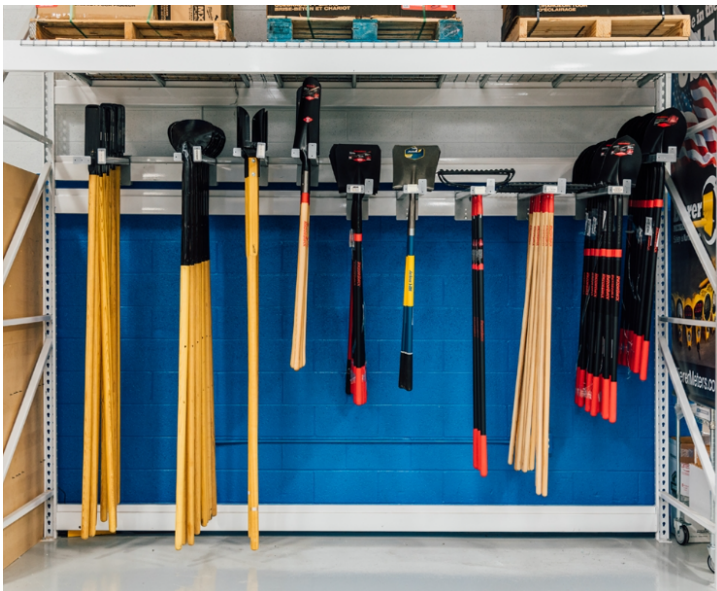
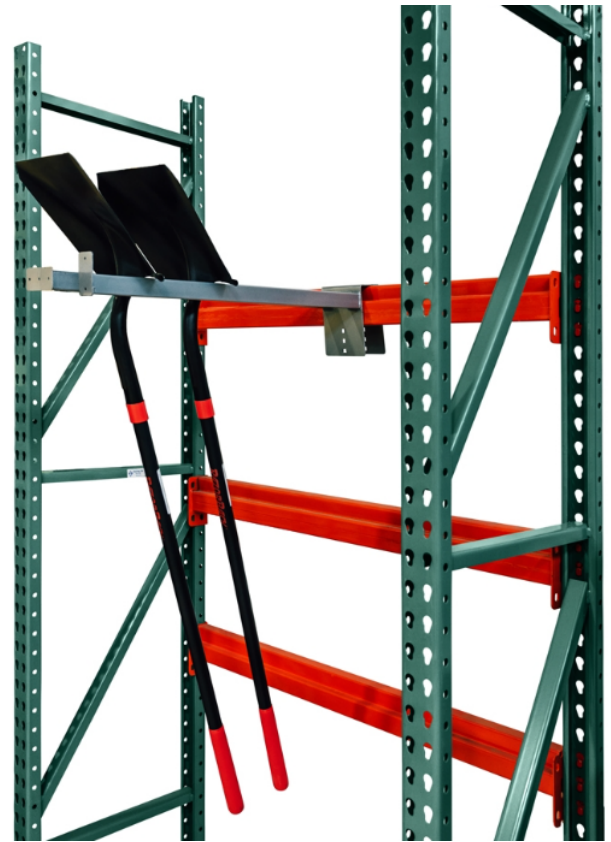
Place double arm tool holders at the top or bottom of a pallet rack bay to organize goods that are harder to store such as brooms, rakes, shovels, and tools. With two arms, the divider is equipped to support both short and long-handled items.

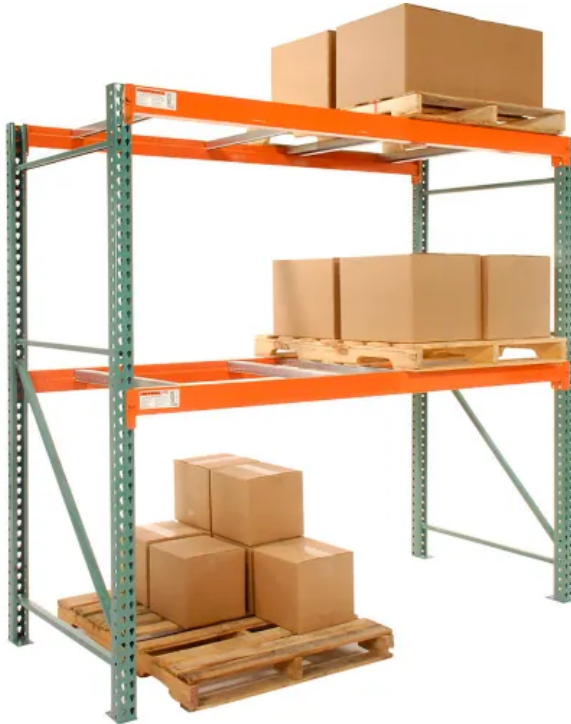
**Global Industrial™ TEAR DROP PALLET RACKS Starter Unit**  
Premium quality pallet racks at a low price. Global Industrial™ pallet racks offer quick and easy, tool free assembly for all your pallet storage needs. These pre-configured starter and add-on industrial storage rack systems are made of durable heavy gauge steel for years of service. Starter Unit includes 2 upright frames and 2 pairs of shelf beams. Heavy duty, one-piece 14 gauge steel uprights allow height adjustments at 2" increments for easy beam adjustment. High strength 15 gauge steel beams have a 1-5/8"H step beam design that accommodates cross bars and decking. Beams provide secure connection to upright frame using a positive 6-way locking action; right to left, front to back and up and down. Lock automatically snaps into place and secures beam. Welded braces provide maximum rigidity and stability. 3-1/4" x 4-1/4" x 12 gauge welded base plate anchors upright to floor and distributes weight evenly. Uprights feature a long lasting epoxy finish. The pallet should overhang the frame by 3" front and back. Interchangeable with Teardrop styles of the following manufacturers: Interlake, Kingway, Steel King, USP, Wireway/Husky, Unarco and Speed Rack. Easy assembly.

**27600 lb rated capacity, higher than other pallet racking in the market. Capacity based on 36" beam shelf spacing.**

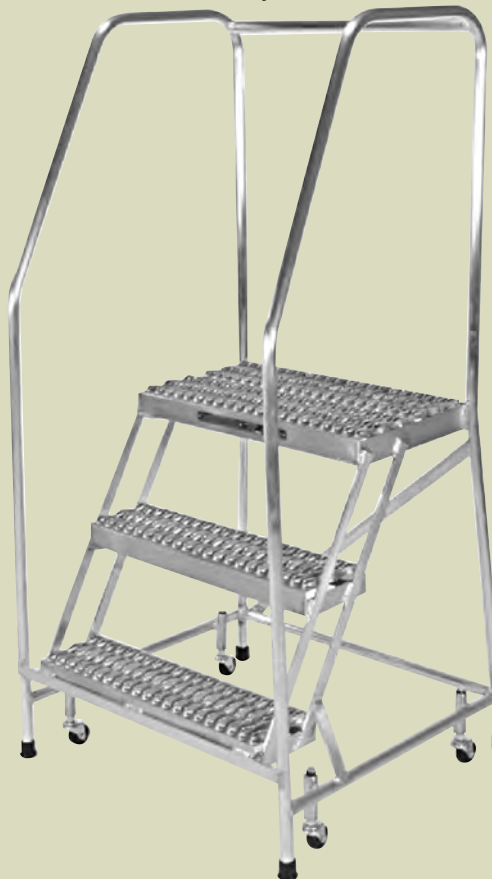
3 STEP  
MODEL NO.  
A3R2630A3

- The structural framework is of 1" O.D. 6061-T6 high strength aluminum alloy tube.
- Both the steps and the top step are 16" or 24" wide and available in solid ribbed extruded aluminum alloy or aluminum grip strut. The steps are 7" deep. The top step is 14" deep.
- All ladders are provided with spring loaded 2" ball bearing swivel brake casters and reinforced rubber tipped legs.
- Ladders are normally furnished with unpainted aluminum mill finish.
- Series A aluminum ladders comply with OSHA 1910.29 and ANSI A14.7 standards with a 350 lb. load rating. Cal-OSHA models also available.
