**Truro Historical Commission**  
**Remote Meeting Agenda**  
**Tuesday, October 1, 2024, at 5:00 pm**

**TOWN of TRURO**  
**Truro Historical Commission**  
**Truro Historical Commission (THC) Meeting Minutes**

The Town of Truro has acquired the Walsh parcel, which includes eight (8) existing wood-frame dwellings and miscellaneous outbuildings on six (6) parcels totaling 7.92 acres and two additional parcels without buildings for a total of 69.8 acres. The Town has a pressing need for additional housing for Town employees, seasonal staff, and others, and wishes to evaluate the structures and the overall site for redevelopment. This may include renovation or replacement of the houses in-place, new free-standing or clustered residential units, or some combination of both. The need for three types of housing has been identified; traditional single-family, transitional (shorter-term) housing for relocated Town employees, and group- or dormitory-style accommodation for seasonal staff. Other housing types or scenarios may be developed as our work with the Town progresses.

Prior to proceeding with full programming and conceptual design of housing alternatives, the Town has asked Weston

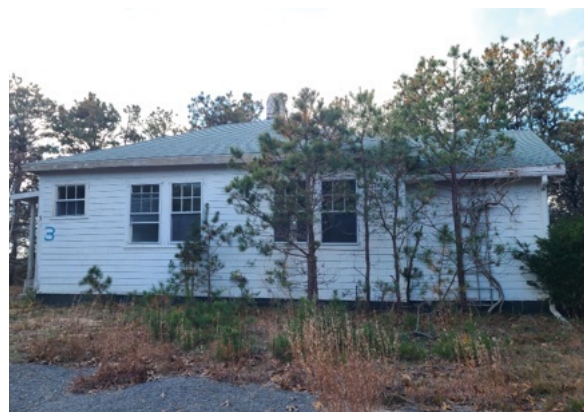
Side elevation with missing rain gutters and overgrown foundation plantings.

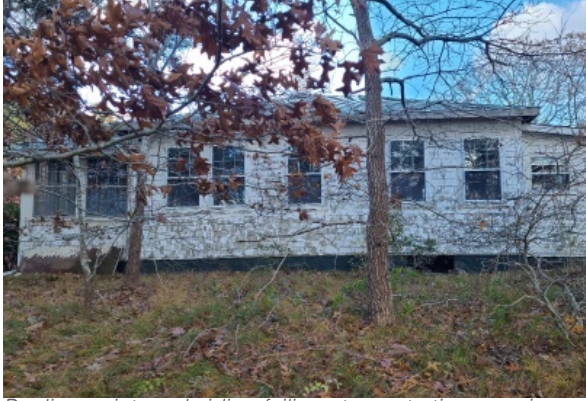
*Peeling paint, and siding failing at penetration openings and rotting at the roof line. Additions to the left and right.*

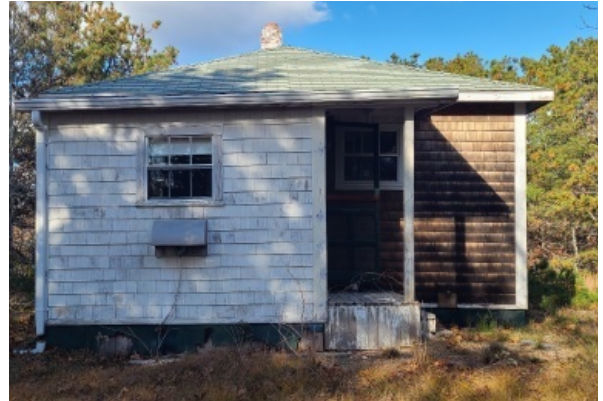
*Rear elevation of kitchen addition accessed by decaying wood stairs.*

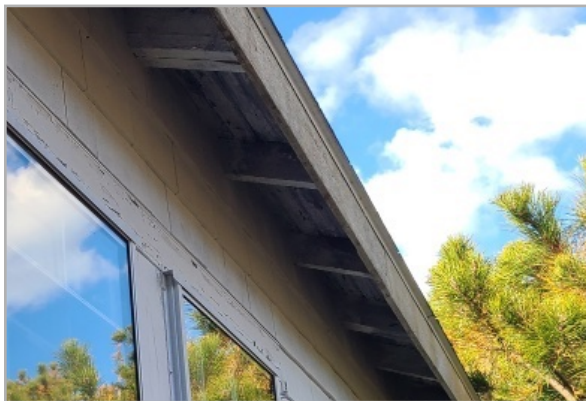
*Exposed roof rafters at eave show signs of rot, and peeling paint on fascia board.*

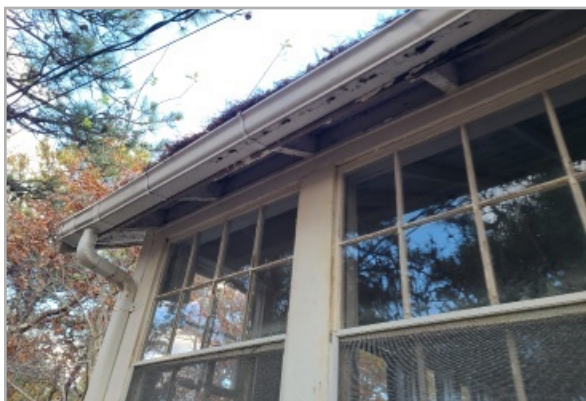
*View of exposed and rotting eave with aluminum gutters sagging from the weight of accumulated organic matter supporting live vegetation.*

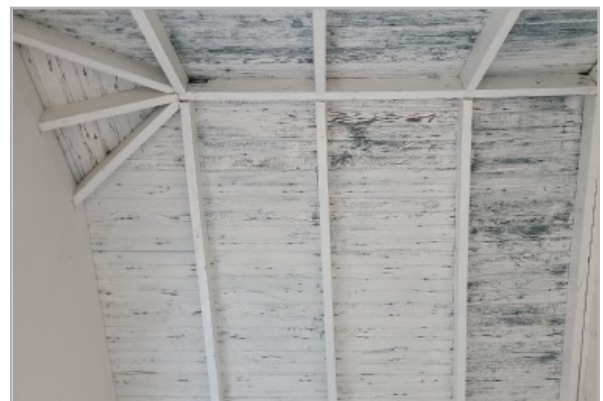
*Interior of roof in front porch addition, with peeling paint and signs of water ingress.*

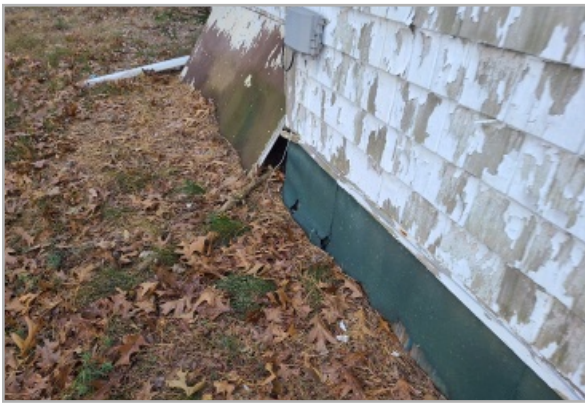
*Deteriorated painted plywood foundation skirting.*

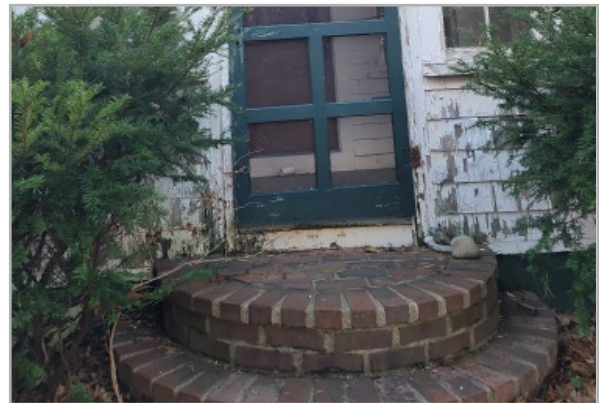
*Brick steps at front entry. Note rotting shingles at bottom courses to brick.*

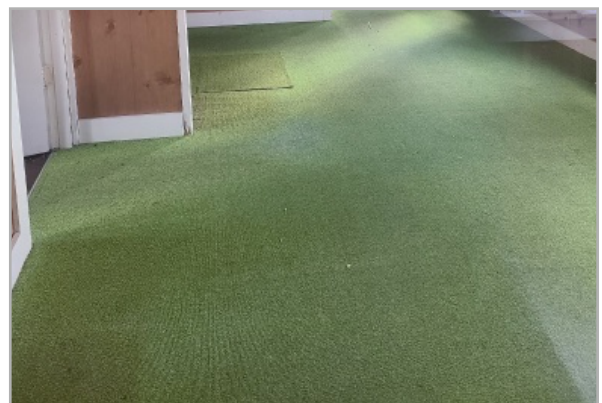
*Synthetic grass carpeting covers a severely uneven wood floor surface due to sagging, undersized floor joists and foundation settlement. .*

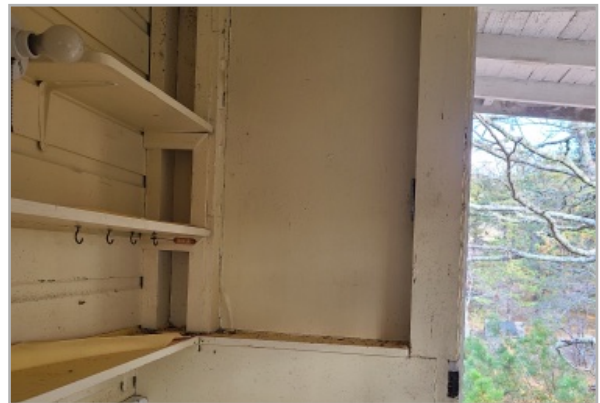
*Kitchen addition wall has an unfinished interior with chipping and peeling paint. Due to the age of the structure, lead paint is assumed at all painted surfaces.*

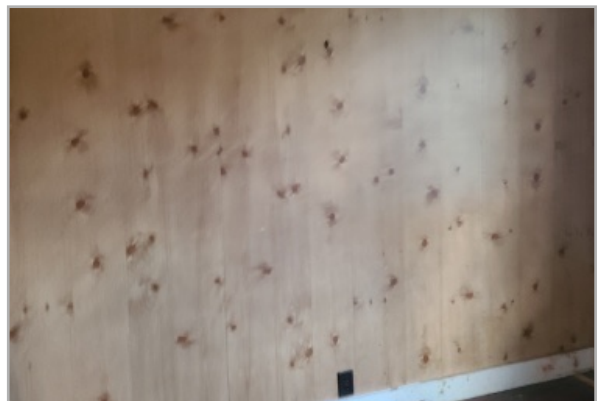
*Wood panel walls, naturally stained with a contrasting base board. There are signs of mold and mildew growth in some areas.*

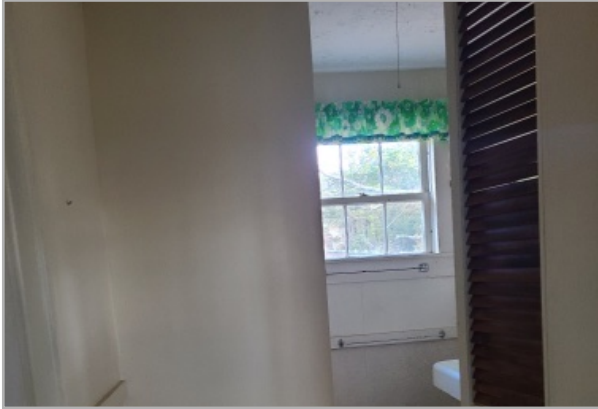
*White plaster walls in bathroom is showing signs of mold and mildew growth.*

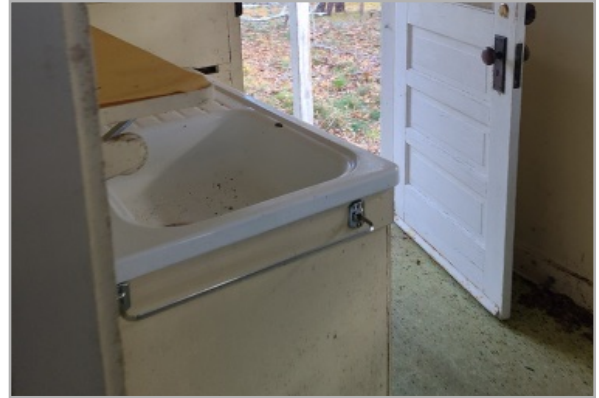
*Porcelain sink and counter unit in kitchen. The green linoleum flooring has tested positive for asbestos.*

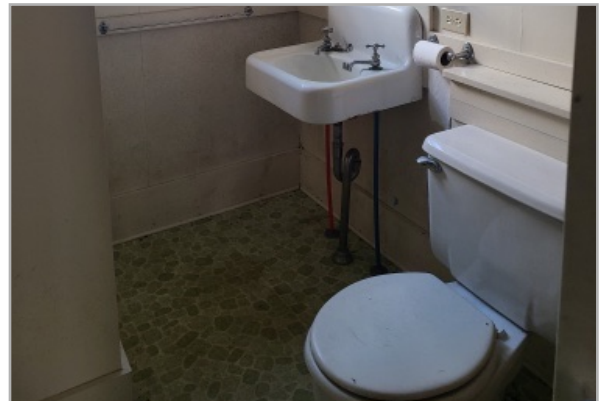
*Wall hung sink with separate hot and cold faucet fixtures. Hazardous non-GFCI, non-grounded electrical outlet next to sink.*

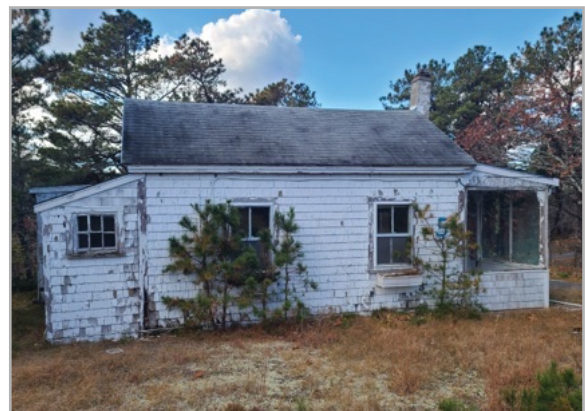
Building siding paint is peeling throughout with rotting deteriorated shingles and wood trim boards.

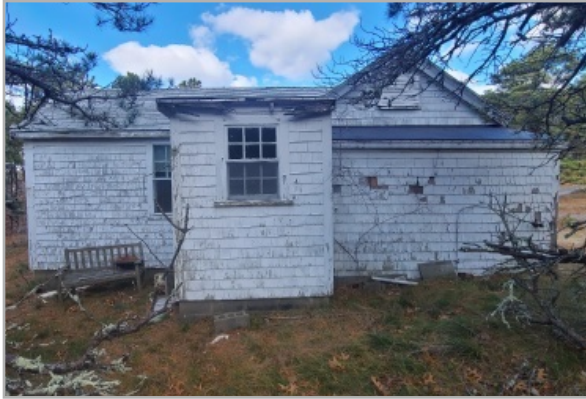
*South face of the building, the paint is peeling and chipping on almost 80% of the wall surface area.*

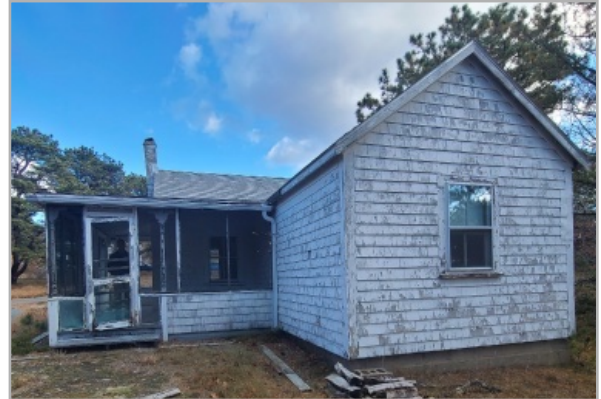
*View of West face of building, the paint is peeling and chipping off of almost 90% of the surface area. The front porch addition is failing as is the masonry chimney.*

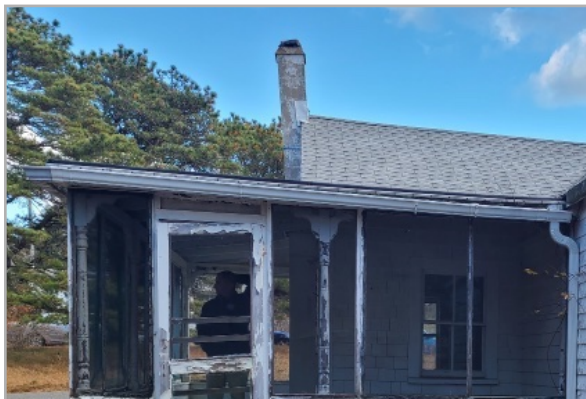
*The front porch addition roof is pitched incorrectly causing water to run towards the gable end of the roof.. This entire construction has degraded and must be demolished.*

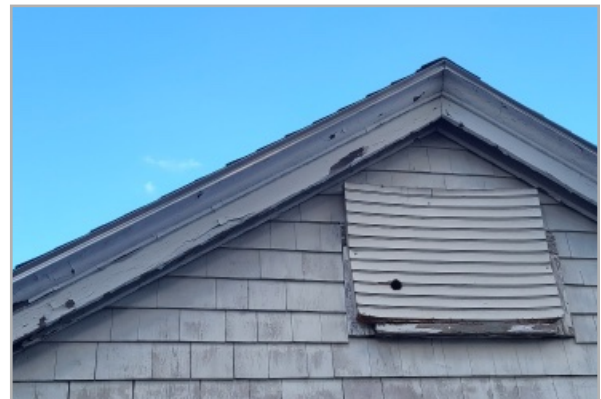
*A view of the rake condition of the original roof. A louver is located at the peak, and has deflected out of its penetration. The rake shows sign of mold between the fascia board and siding.*

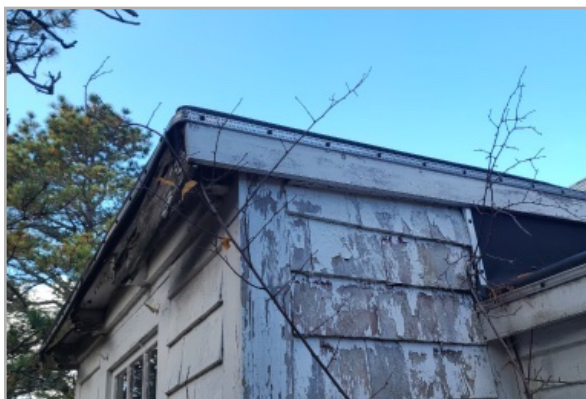
*View of back additions, the membrane roof has failed and the fascia board has rotted out exposing the structure behind to the weather. The building siding has also been patched with a membrane sheet to the right.*

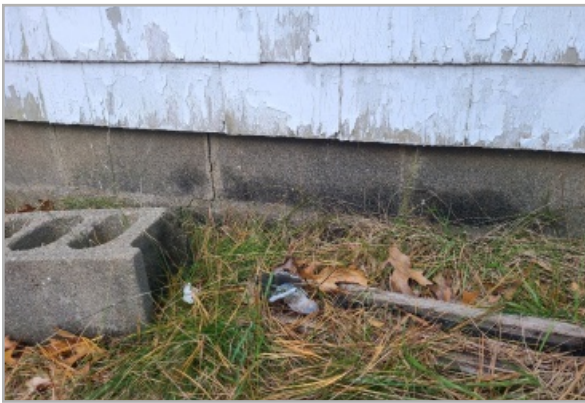
*CMU foundation with discoloration indicating water damage within, and cracking in the mortar joints.*

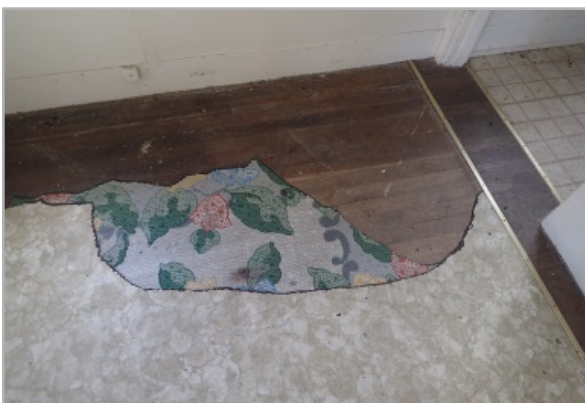
*View of multiple layers of floor coverings that have crumbled away to expose the original wood floor below. Sagging and sloping of floors and evident wall cracking suggest the foundation has settled over time.*

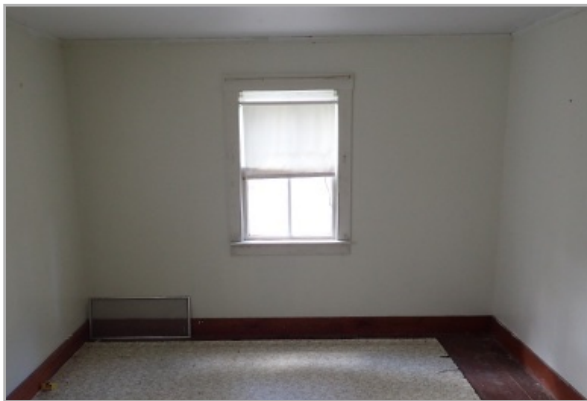
*View of painted interior wall with base trim, there are areas of mildew growth on the wall panels.*

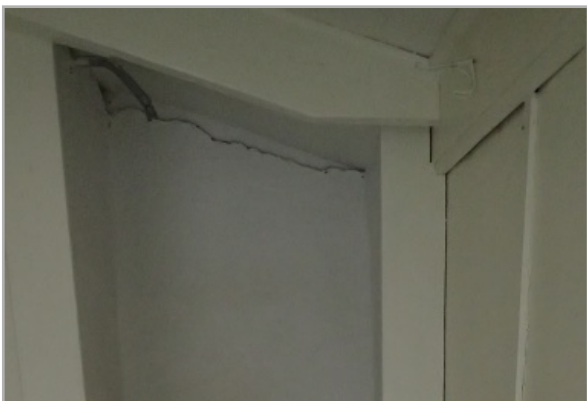
*View of crumbling wall and ceiling due to insufficient moisture protection, and must be investigated for extent of damage.*

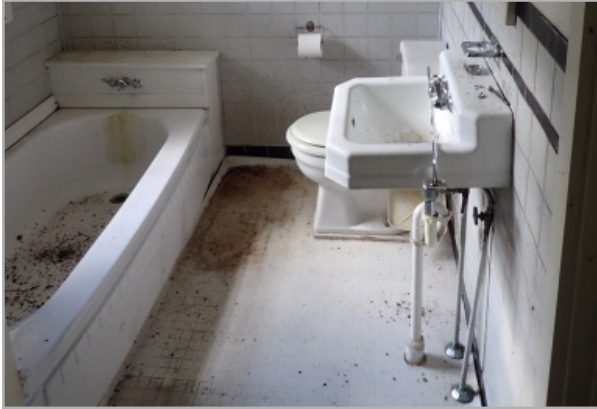
*View of bathroom with non-compliant sink fixture, a bathtub with non-compliant hardware, and an outdated toilet that needs replacing.*

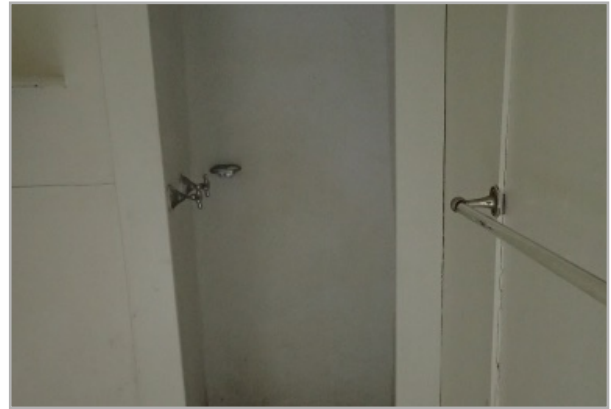
*Small shower stall with separate hot and cold water fixtures.*

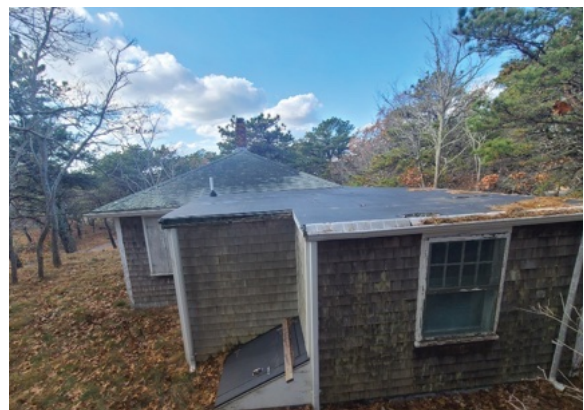
View of East elevation, there is a rear addition, with discoloration throughout siding indicating water damage.

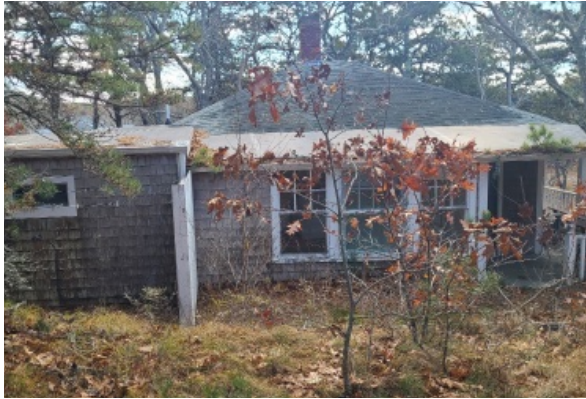
Northern face of the buildin. Most windows are single paned wood windows lacking aluminum storms. A few windows have wood framed storms.

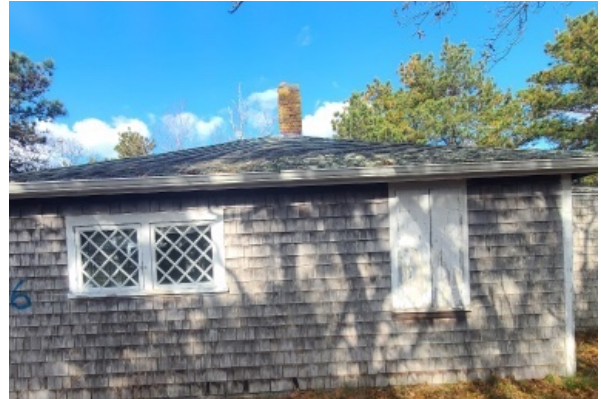
Southern face of the building, with one window opening boarded up. The sill of the covered window is rotted with signs that it is allowing water into the building.

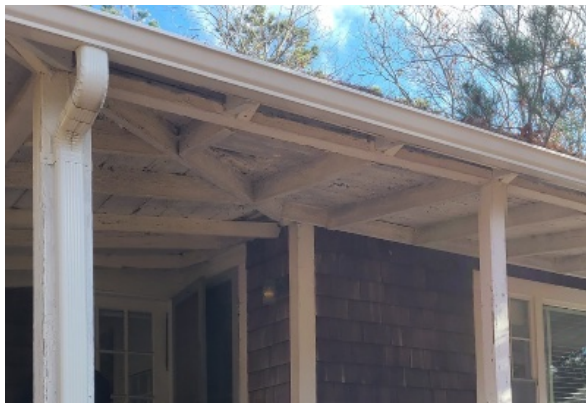
Front porch addition roof is an extension of the original roof and is secured into the exterior wall structure. The building structure is insufficient to support the porch canopy weight

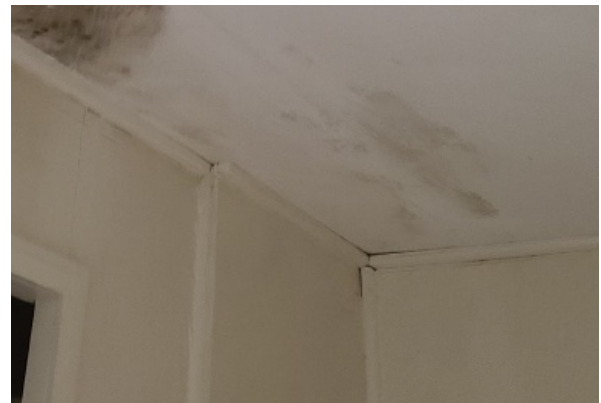
View from the interior of water damage and mold seen in the ceiling indicating multiple areas of water penetration into the roof.

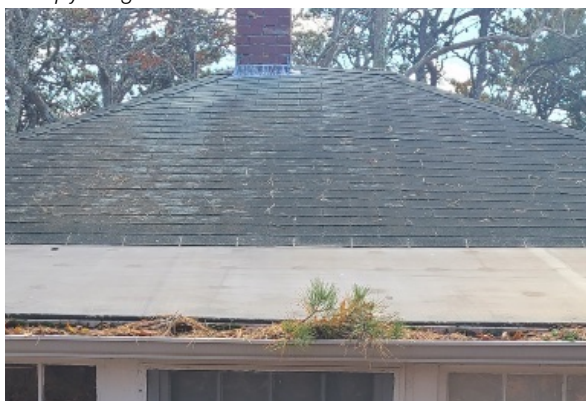
View of side addition membrane roof in relation to the original hip roof. The asphalt shingles are beyond their useful life. The gutter is filled with organic material supporting vegetative growth.

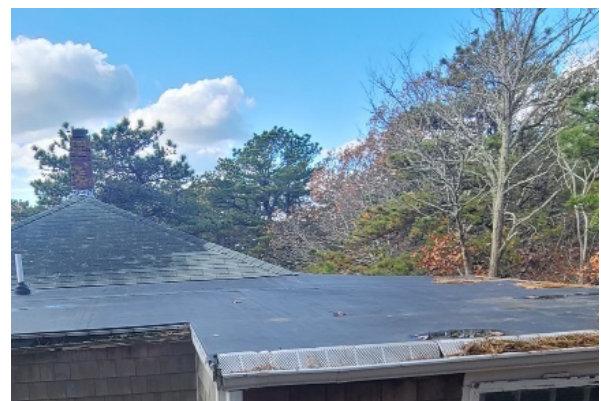
View of rear addition membrane roof in relation to original asphalt shingle roof. Evidence of ponding can be seen in the membrane roof, with vegetation build up in the gutter as well.

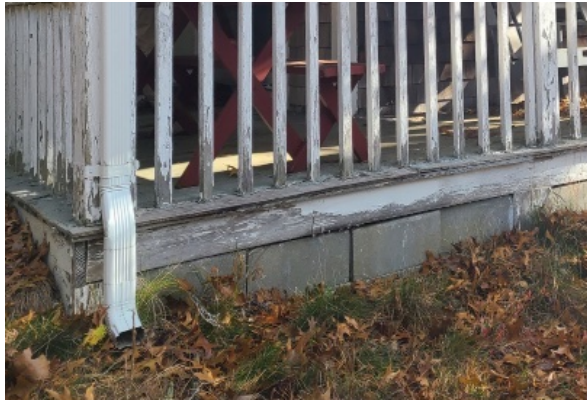
CMU on grade foundation for porch addition is an insufficient structure, and the wood framing is in contact with the ground on the northern side (left).

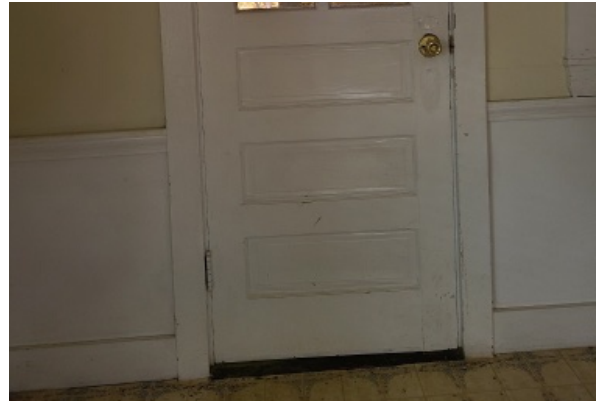
Door threshold in relation to the floor deflection, indicating a sloping settling foundation.

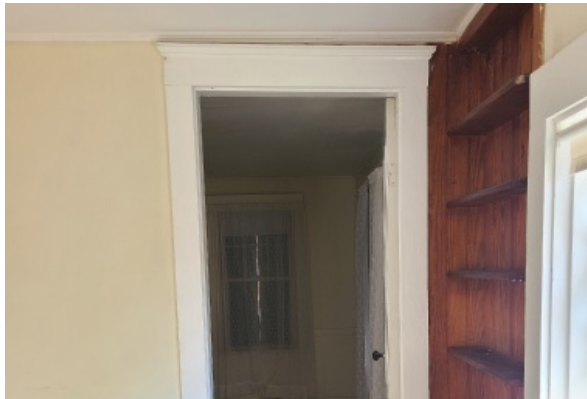
Interior door frame that is tilted, illustrating the failing foundation. This entire front room is sloping out from the central point of the inner most wall (facing here). The door opening width is 26\"/>

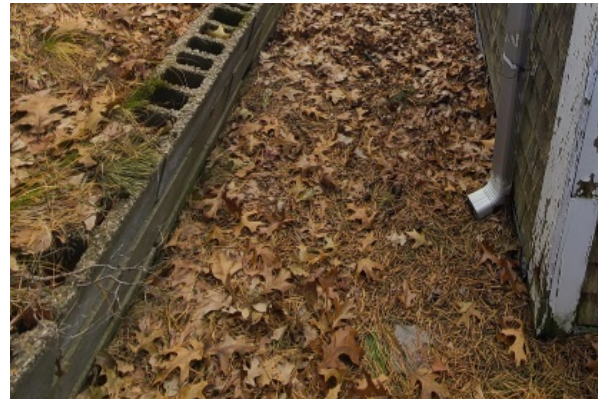
CMU retaining wall off set from foundation does not provide enough depth to keep the exterior building envelope from contacting the ground resulting in rotting and decaying of the exterior wall fabric in this location.

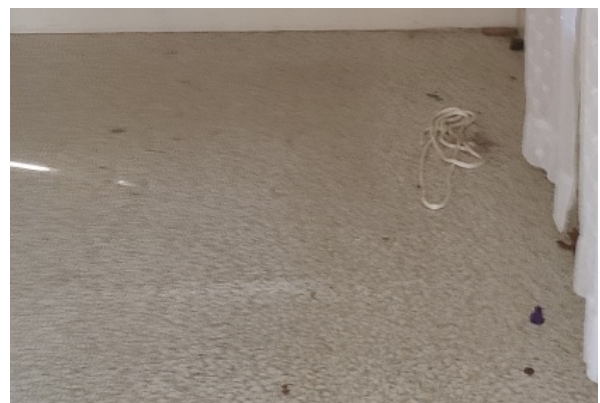
Sheet flooring with signs of degradation throughout.

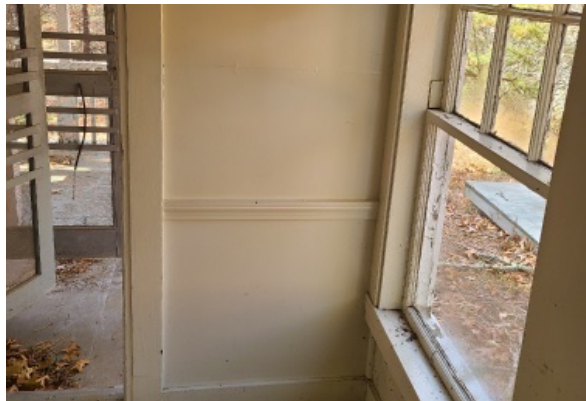
*Exterior corner of side addition with painted plaster walls. The window is not protected with a storm window and is in poor condition as a result.*

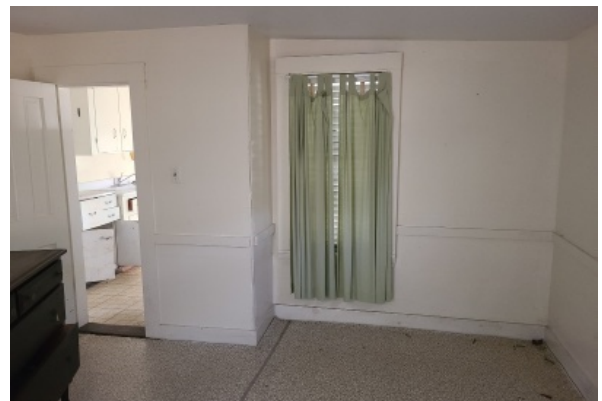
*Painted plaster wall with signs of mold and mildew growth. The window in this room is now interior due to the side addition.*

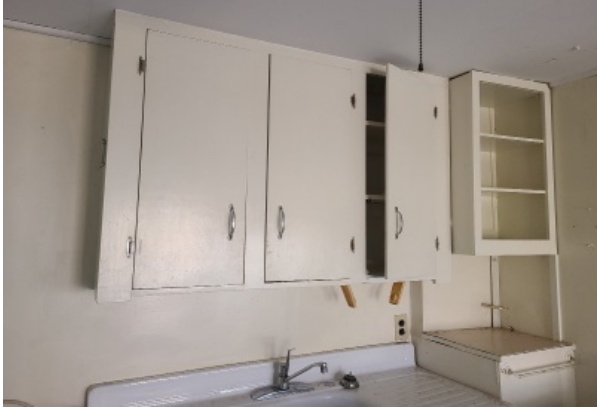
*View of kitchen cabinetry and in counter sink. The hardware for the sink is non-compliant, and the cabinetry needs replacing due to structural concerns.*

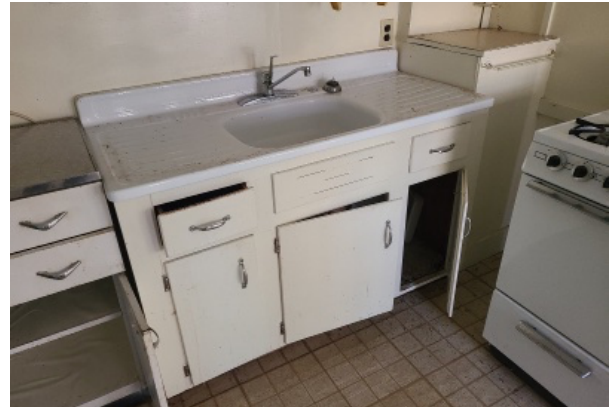
*In counter sink and cabinet storage underneath. The cabinets and drawers could not close due to warping and the deflection of the floor structure below.*

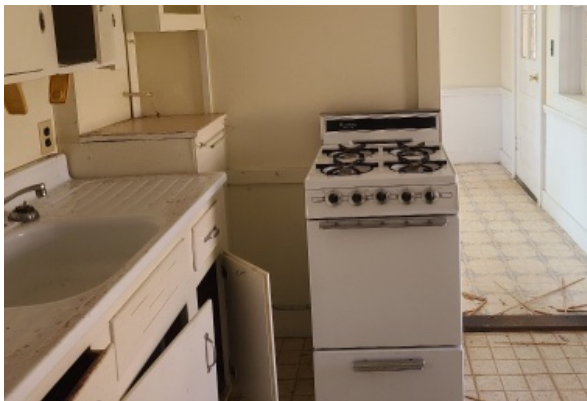
*Stove/oven unit is outdated and needs replacing. There is no exhaust fan above the propane gas fueled burners.*

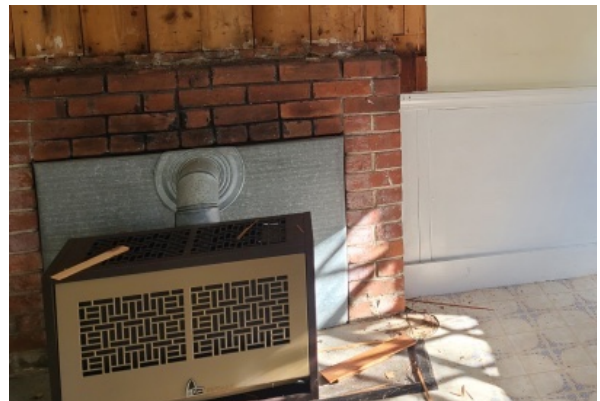
*Propane fueled central heating unit with signs of water damage from the chimney.*

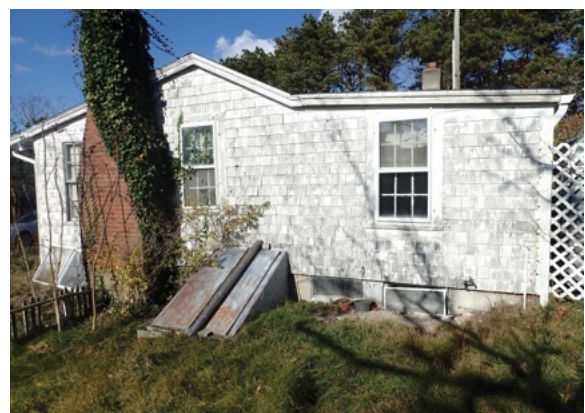
South elevation, vegetation penetration can be seen.

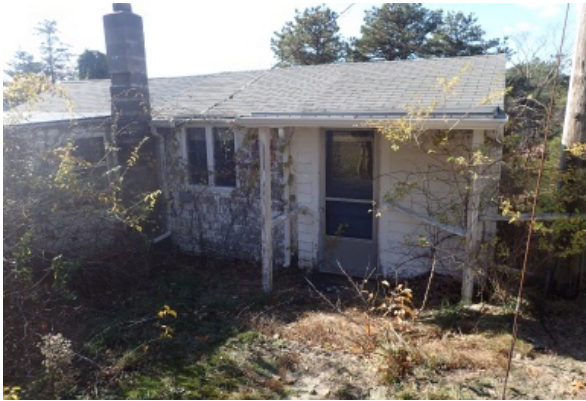
*East elevation has excessive vegetation overgrowth that has penetrated the shingles in some areas.*

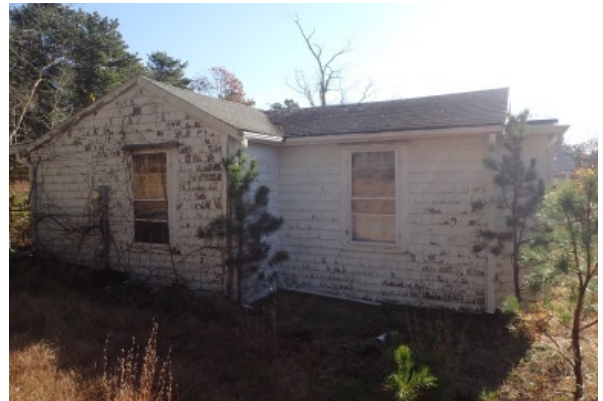
*North face of building where exterior walls meets grade. Peeling and chipping of paint from the bottom up indicated water penetration from the base of wall.*

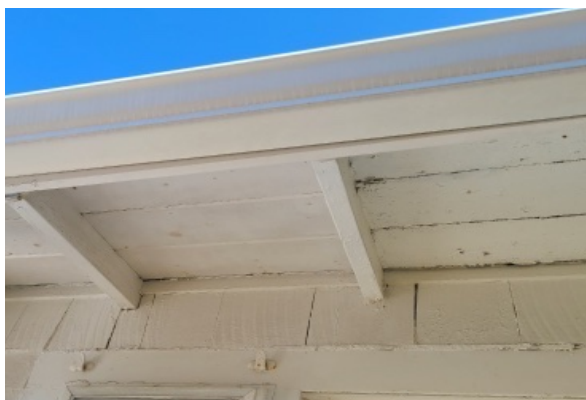
*View of the roof eave condition where the paint is chipping between the sheathing boards. The peeling is not uniform throughout indicating that the roof eave may only have water penetration in just those areas.*

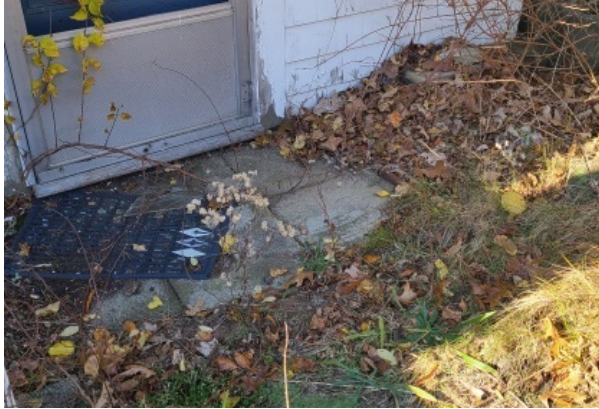
*Concrete landscaping tiles at grade at the back entry to the building that have become obscured by the ground and vegetation encroachment and must be rehabilitated.*

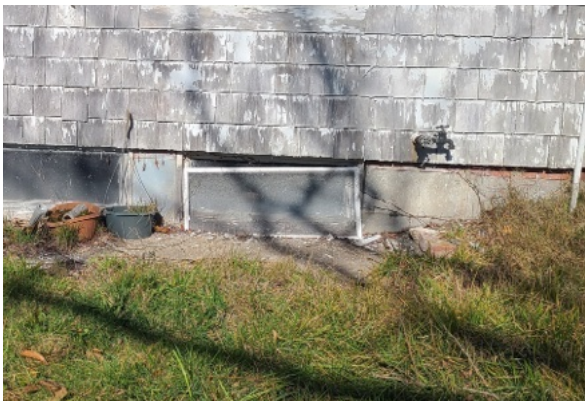
*View of cracked parged CMU foundation. The basement window in this area is missing, allowing for animal habitation.*

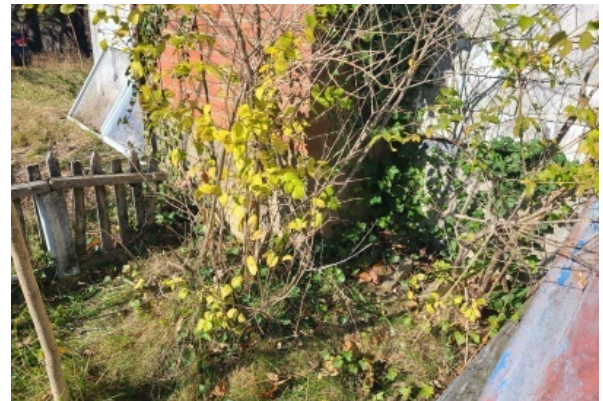
*View of vegetation overgrowth penetrating chimney and wood shingle siding.*

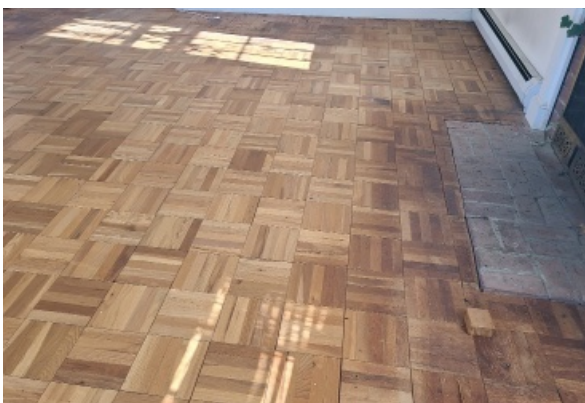
*Wood parquet tile flooring with signs of warping and deflection throughout. Asbestos was dedected in the flooring.*

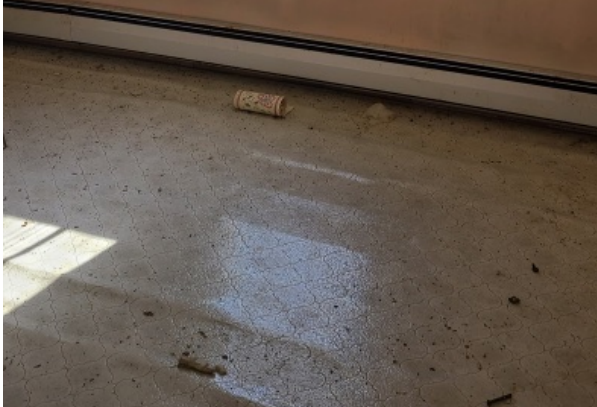
*View of sheet flooring with evident signs of deflection occurring.*

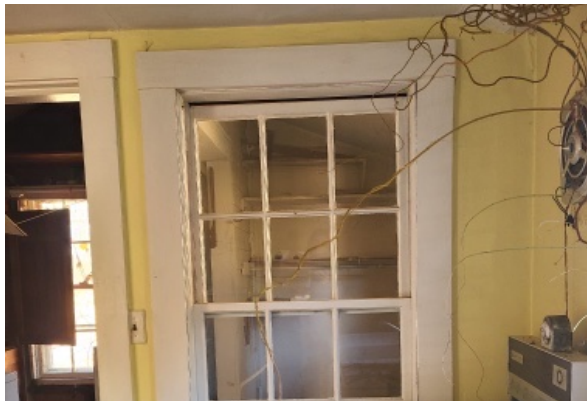
*Exterior window that became interior with the side addition. To the right is a through-wall exhaust fan with vegetation penetration.*

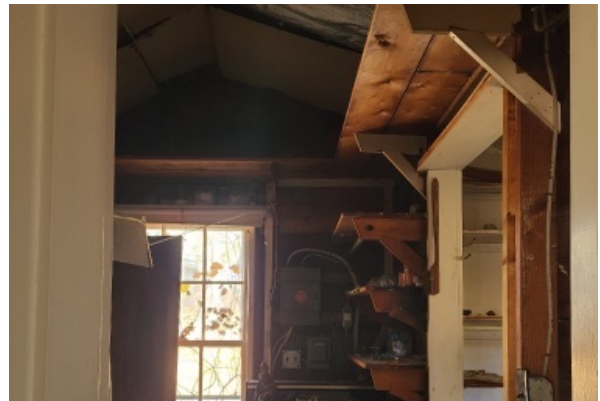
*View into side addition, walls lack interior finishes revealing open stud bays without insulation.*

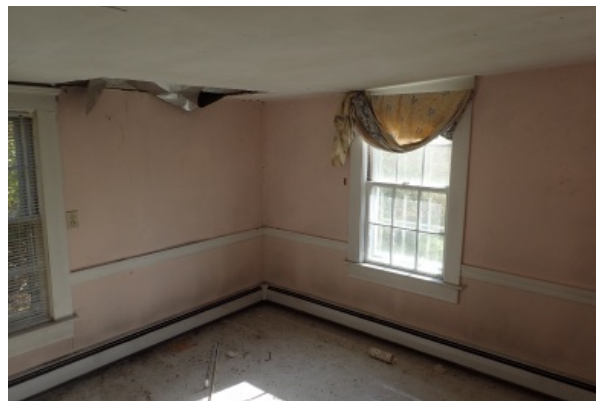
*Painted plaster wall with trim about openings and at the base, as well as trim board at about 3' above finish floor. Paint shows signs of mold and mildew growth. The very low 6'-10" ceiling is open to the roof structure in one area.*

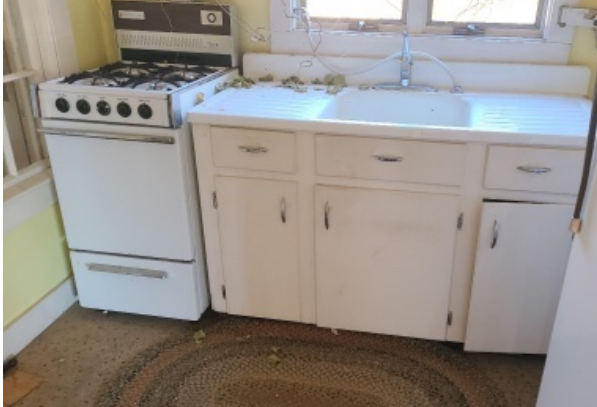
*Stove/oven fixture with counter top sink fixture. The hardware on the sink is non-compliant, and the stove/oven fixture is outdated and needs replacement.*

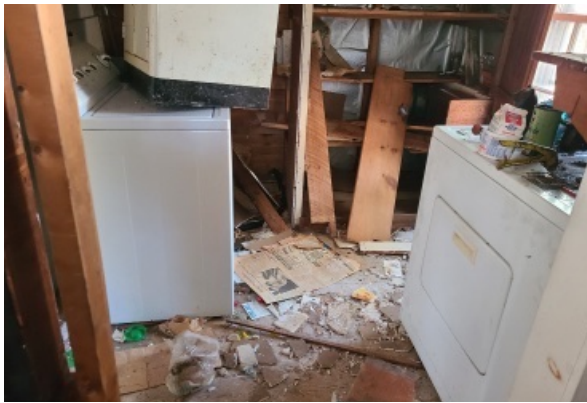
*A set of clothes washer and dryer, as well as another unidentified fixture on top. The condition of these fixtures are unknown, but any utility connection must be updated.*

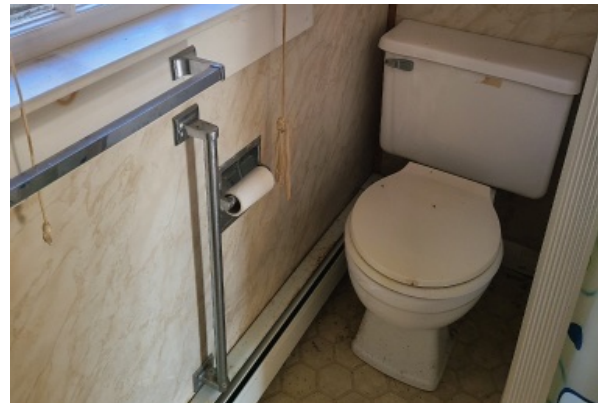
*Toilet fixture with signs of damage due to normal wear and tear. There are nonconforming guardrails in this location as well.*

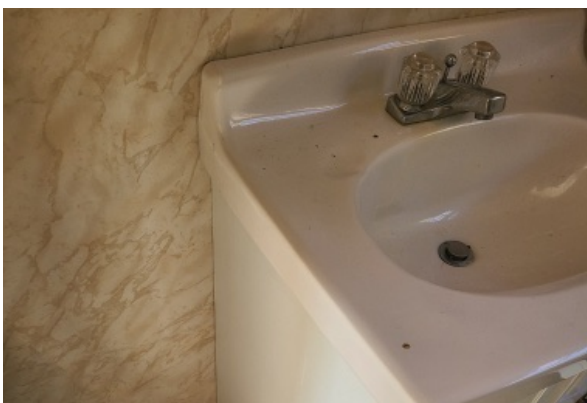
*Bathroom fixture with non-compliant hardware.*

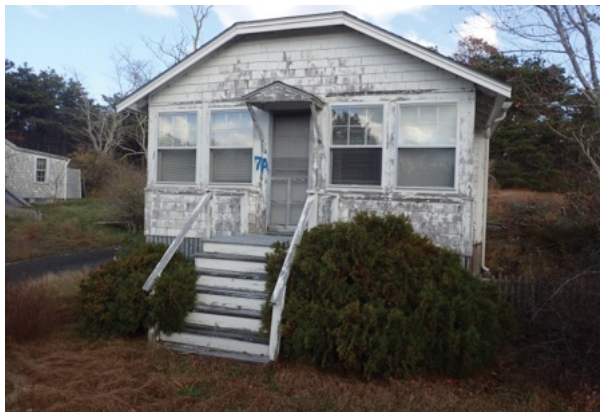
Front of cottage, front canopy roof assembly are rotted and insufficiently supported. Fascia board can be seen to be rotting as well.

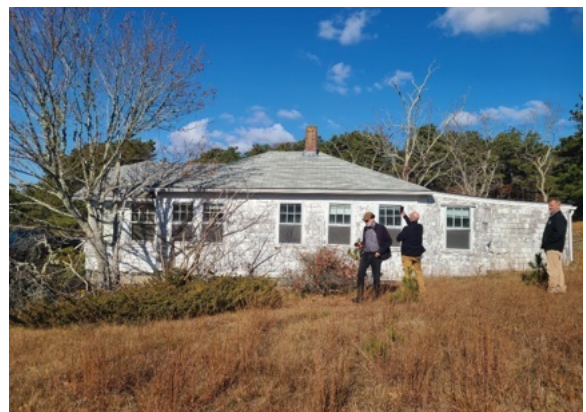
Southern face of cottage, front and rear additions are apparent. This face is missing at least 50% of its paint.

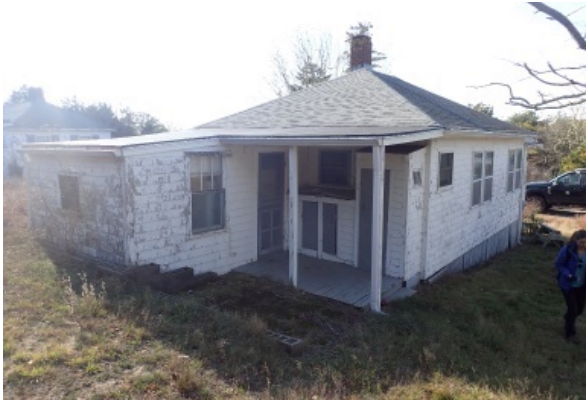
*There is a covered porch at the rear of the cottage, with a shower stall and cabinets. All painted surfaces are chipping and peeling, and signs of mildew at the porch.*

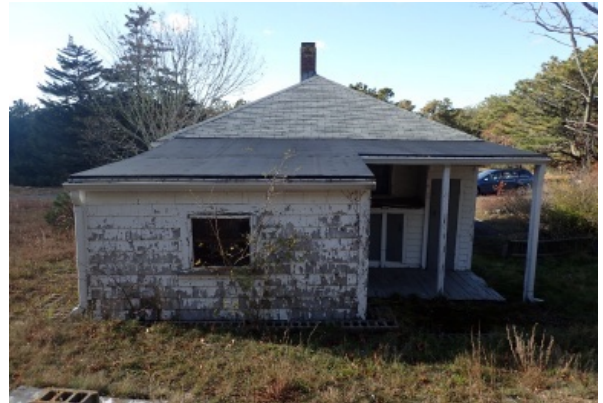
*View of rear addition to the East, the paint has chipped and peeled off of most of the siding. The window in this wall shows signs of water penetration about the perimeter.*

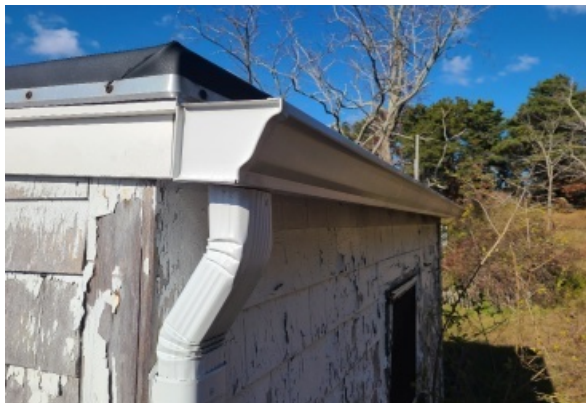
*View of typical gutter and downspout condition at this cottage. The connection of the gutter to the roof eave is non-compliant, and the rust apparent in the fastening screws indicates a need for roof replacement.*

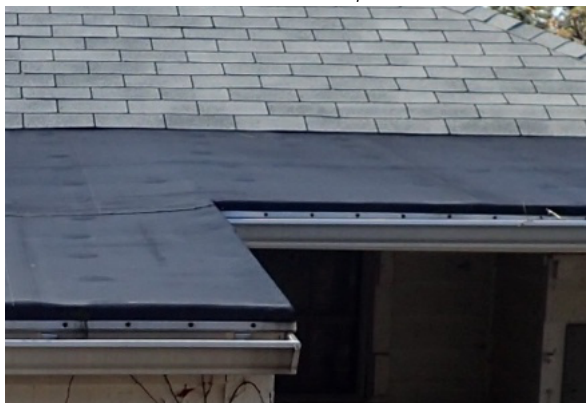
*View of membrane roof of the rear addition, this roof has a significantly lower pitch than the original roof, and is showing signs of deflection in the structure.*

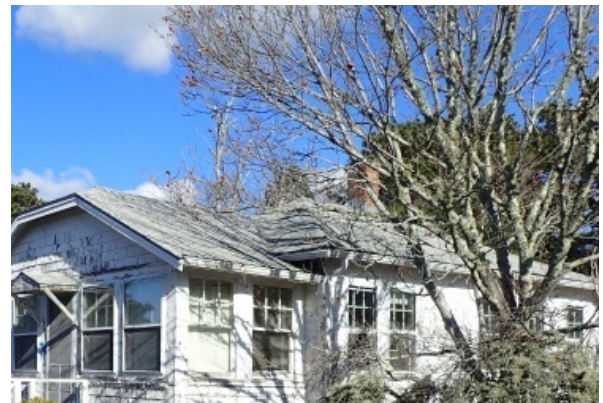
*Cottage roof condition with front addition roof rake meeting the original building siding below the original roof eave. This roof construction is non-compliant and must be made to be so.*

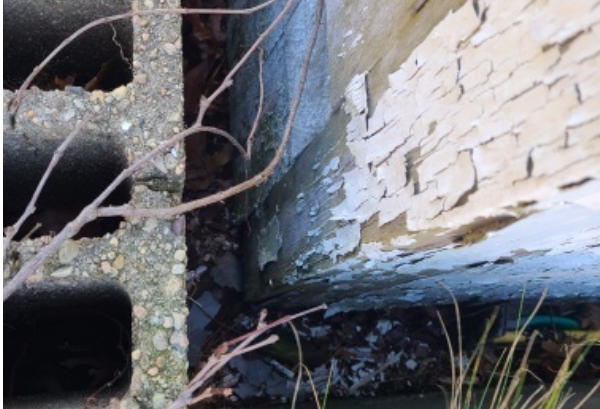
View of CMU retaining wall slightly offset from building siding. Paint has peeled from the base of wall up, indicating water has penetrated the CMU to the siding.

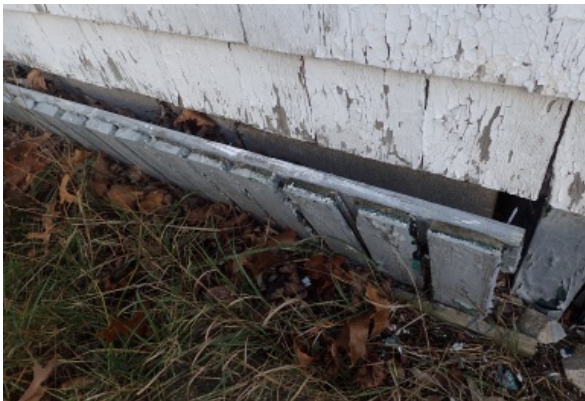
Wooden foundation enclosure rotting and detached from the building. Signs of past reinforcement efforts with a horizontal 1x3 can be seen at the very base.

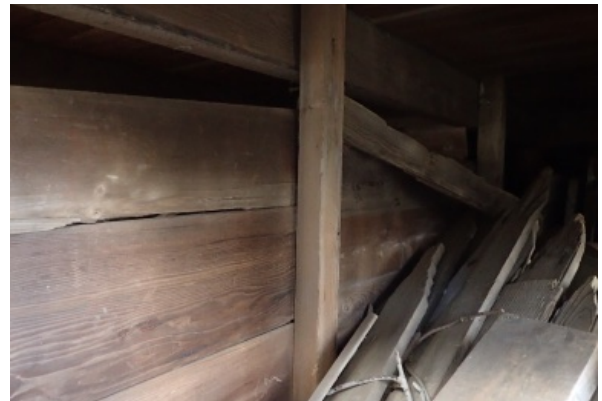
View into foundation crawl space. Insufficient floor supports can be seen, and a wood board partition dividing the space into storage and inaccessible.

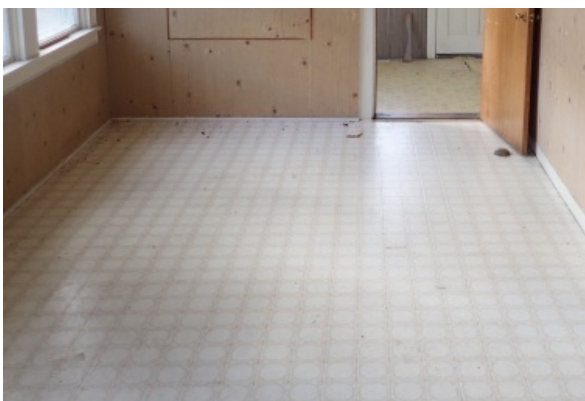
Wall to wall sheet flooring with word spots and some crumbling at the edges.

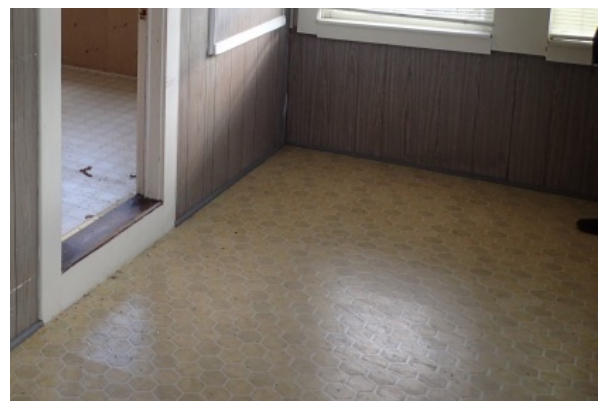
Change in material between rooms, and significant change in floor elevation. Floor sheet finish shows signs of deflections throughout.

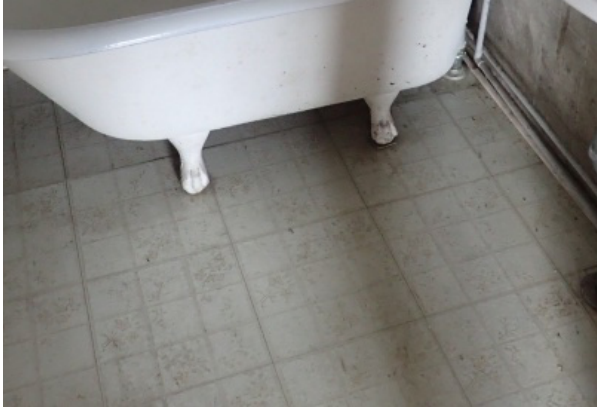
*Sheet tiling in bathroom that is crumbling at the edges and seams.*

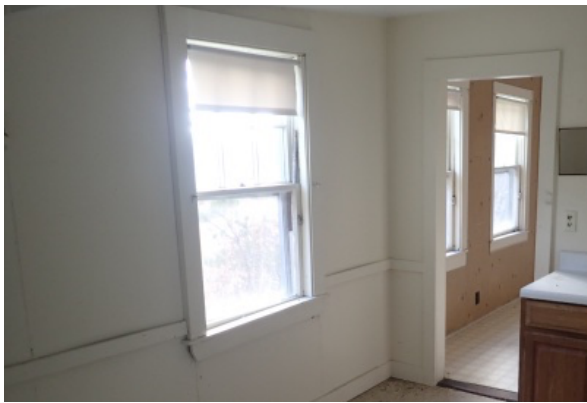
*Painted plaster wall with trim about openings and at the base, as well as trim board at about 3' above finish floor. Paint shows signs of mold and mildew growth.*

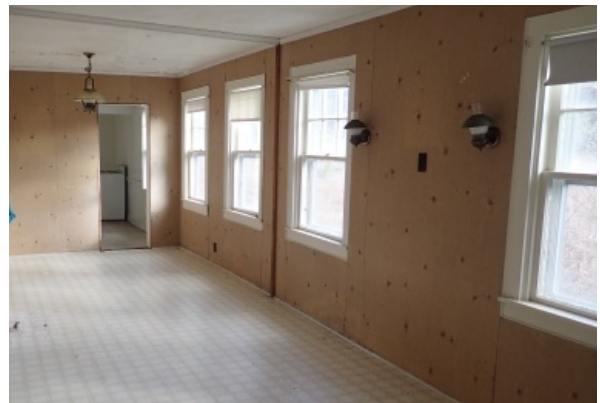
*Floor to ceiling wood paneling with base and crown molting. There is some rippling indicating some deflection occurring from the interior structure.*

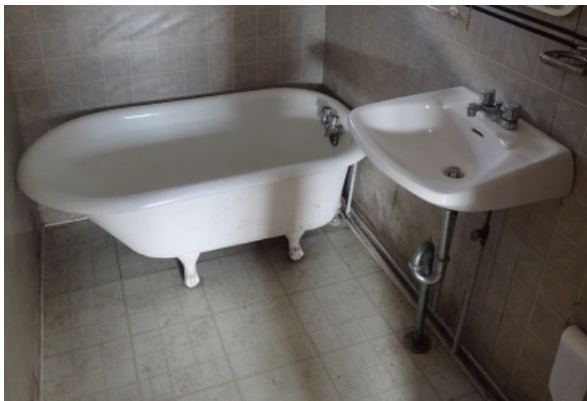
*Sink and bathtub, both with non compliant hardware. Toilet is also present as well in this bathroom.*

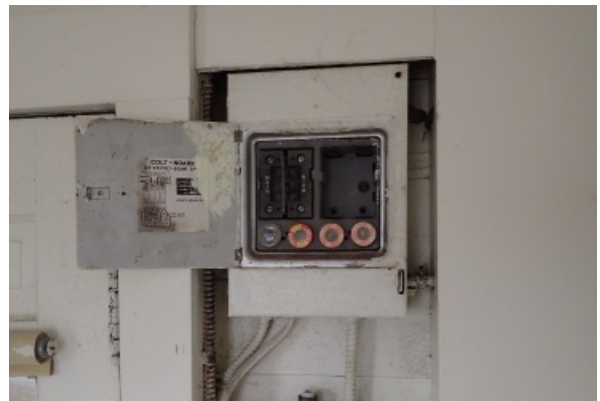
*Conduit box with original fuses is non compliant and must be removed and replaced with up-to-date fixture and wiring.*

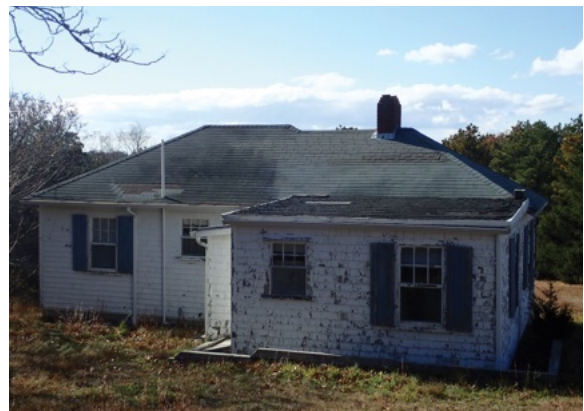
The cottage has gutters at every eave, but some downspouts are missing, and all aluminum is failing.

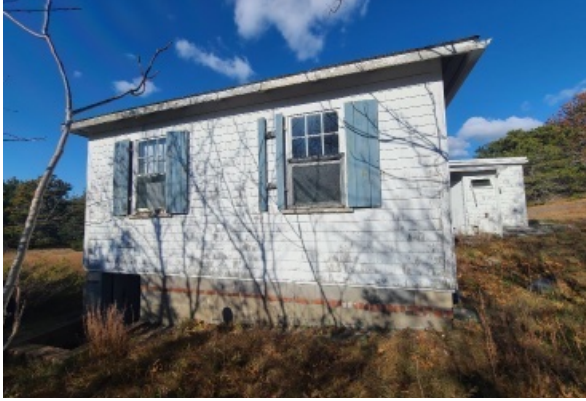
*South elevation with access door to crawl space/basement is to the left. Most windows are without storm window protection.*

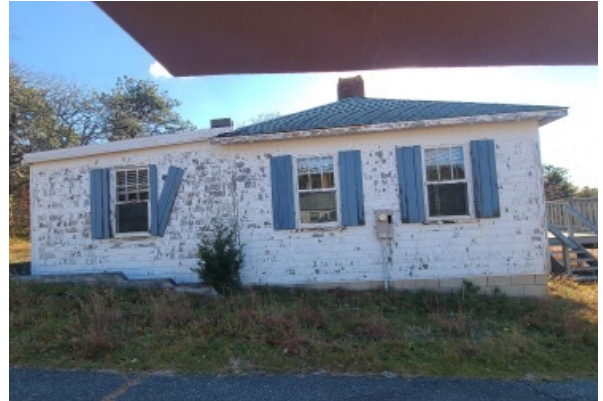
*North elevation, bedroom addition to the left has with damaged window and peeling paint.*

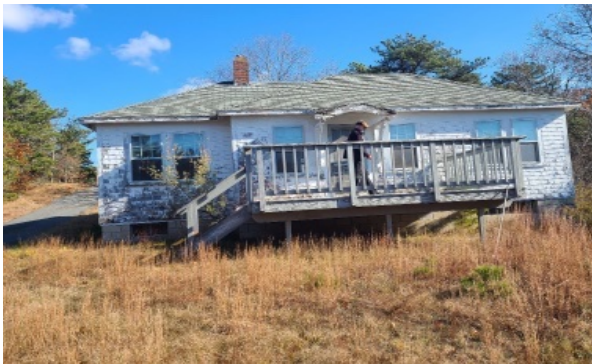
*Shingled eyebrow canopy over front entry is rotted and failing. The fascia board is damaged and rotting at the entire perimeter of the roof. The wood deck is not worth saving.*

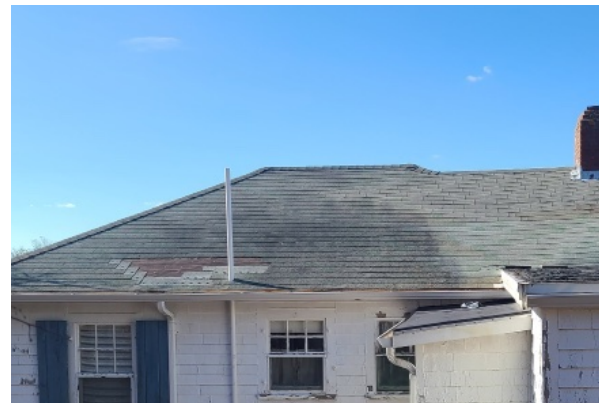
*Patched asphalt shingle roof past it's useful life.*
