**Truro Historical Commission**  
**Remote Meeting Agenda**  
**Tuesday, October 1, 2024, at 5:00 pm**

**TOWN of TRURO**  
**Truro Historical Commission**  
**Truro Historical Commission (THC) Meeting Minutes**

The Town of Truro has acquired the Walsh parcel, which includes eight (8) existing wood-frame dwellings and miscellaneous outbuildings on six (6) parcels totaling 7.92 acres and two additional parcels without buildings for a total of 69.8 acres. The Town has a pressing need for additional housing for Town employees, seasonal staff, and others, and wishes to evaluate the structures and the overall site for redevelopment. This may include renovation or replacement of the houses in-place, new free-standing or clustered residential units, or some combination of both. The need for three types of housing has been identified; traditional single-family, transitional (shorter-term) housing for relocated Town employees, and group- or dormitory-style accommodation for seasonal staff. Other housing types or scenarios may be developed as our work with the Town progresses.

Prior to proceeding with full programming and conceptual design of housing alternatives, the Town has asked Weston

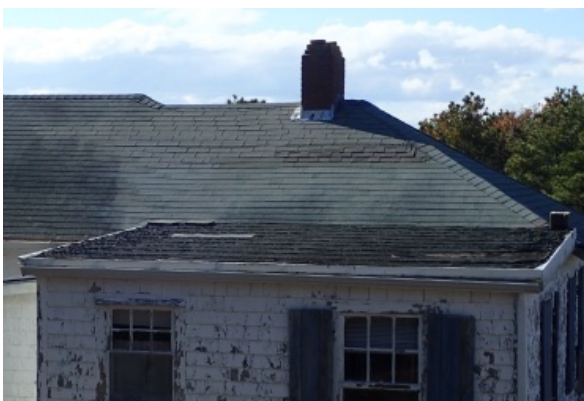
*Poorly constructed addition with degraded asphalt singled low pitched shed roof.*

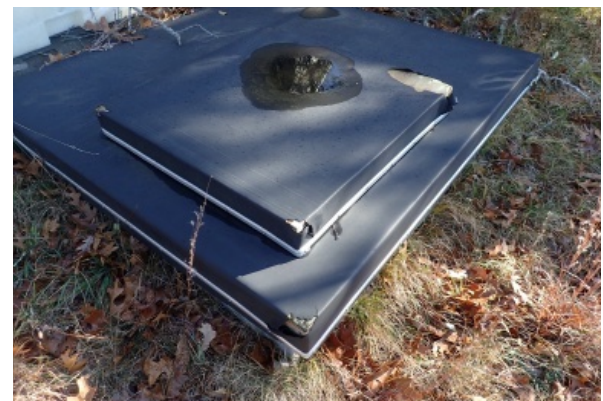
*Membrane roof assembly nearby building similar to other membrane roof constructions on the property. Failure at the corners and edges indicates age and needs replacing.*

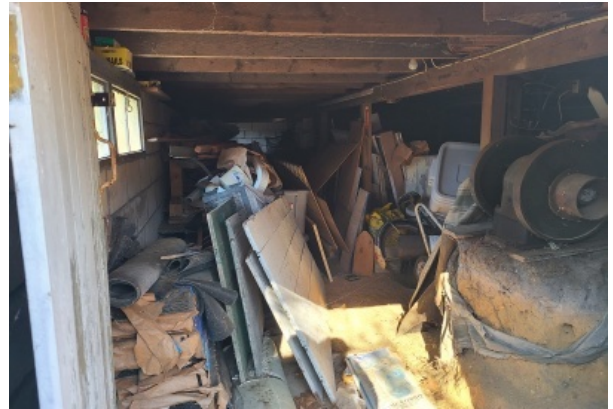
*View inside crawl space/basement.*

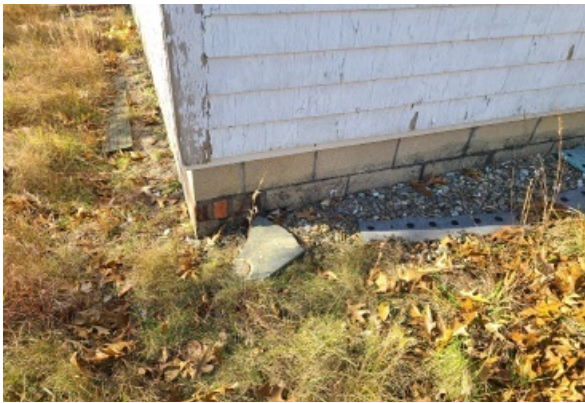
*CMU foundation wall at grade, with brick patching seen in the corner.*

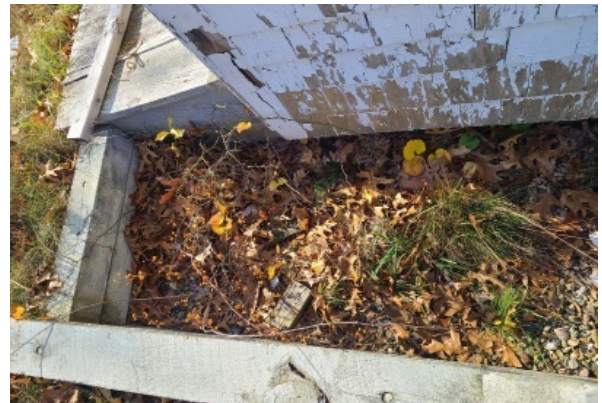
*Insufficient wood retaining wall set back from building face.*

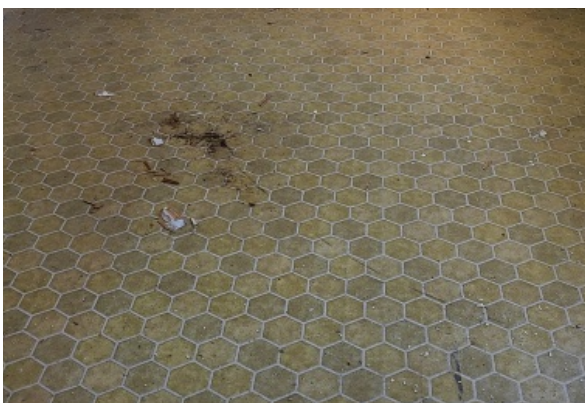
*Worn and damaged sheet flooring.*

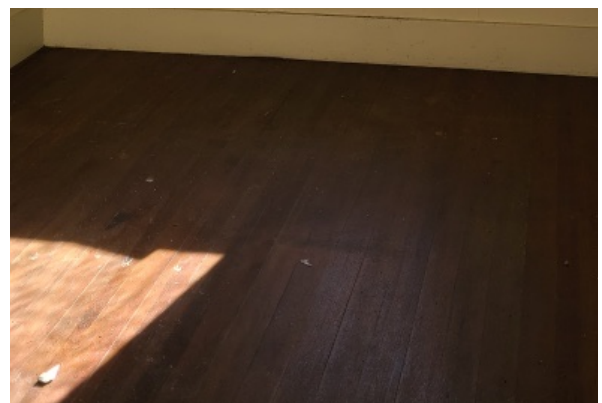
*Hardwood flooring needs restoring, and has a slight pitch indicating foundation settlement.*

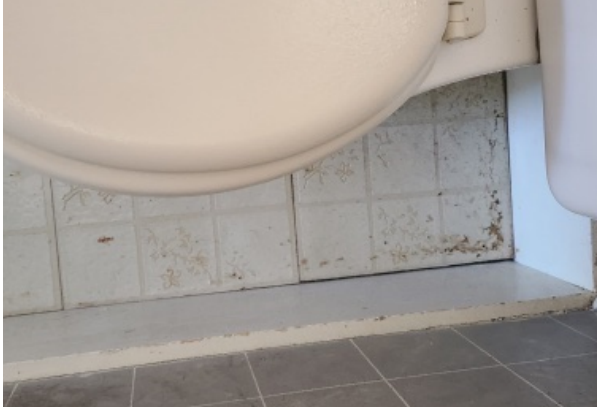
Sheet tile flooring in full bathroom. Tiles have become unsecured in areas and failing.

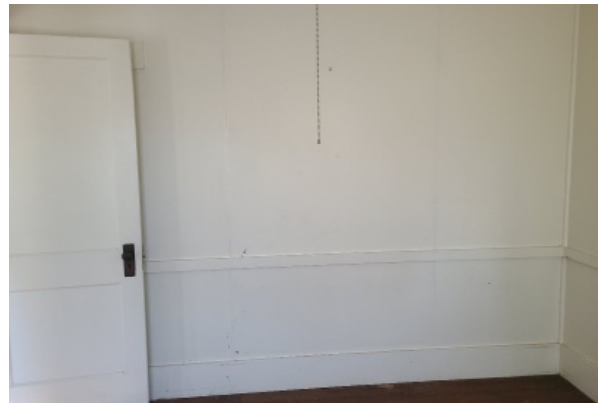
Painted plaster wall with corner and base trim, with trim board at about 3' above finish floor. Paint shows signs of mold growth and the seams between panels have become visually apparent.

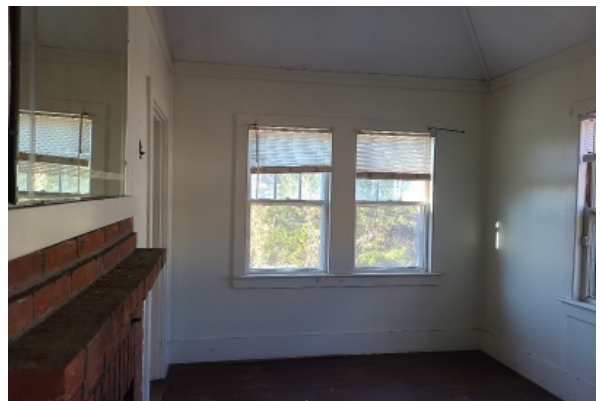
Painted plaster wall with base board trim and crown molding. Trim around window frame is beginning to separate from the wall, and needs replacing. Window hardware at the top is damaged and must be removed.

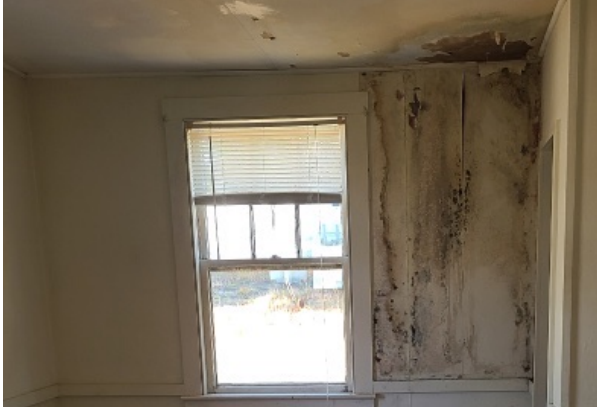
*Interior wall with severe water infiltration and resultant mold.*

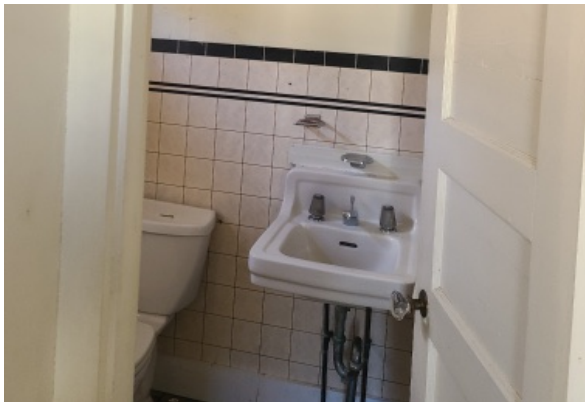
*Half bath with sink and toilet. Sink fixture is non compliant.*

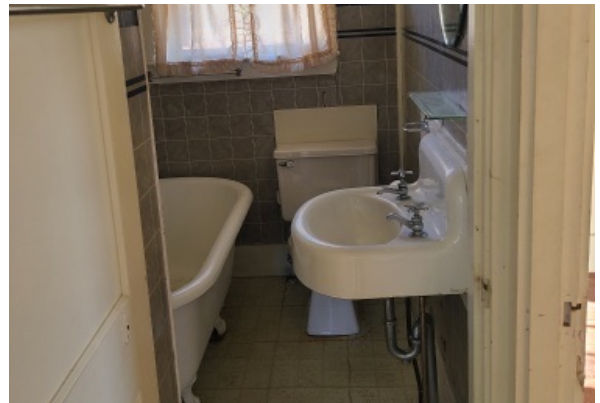
*Full bath with toilet, sink, and bathtub. Sink fixture is non compliant, and bathroom layout is unacceptable by code.*

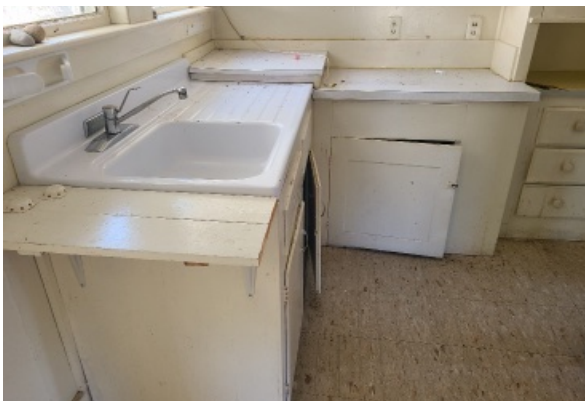
*Counter sink, with non compliant hardware.*

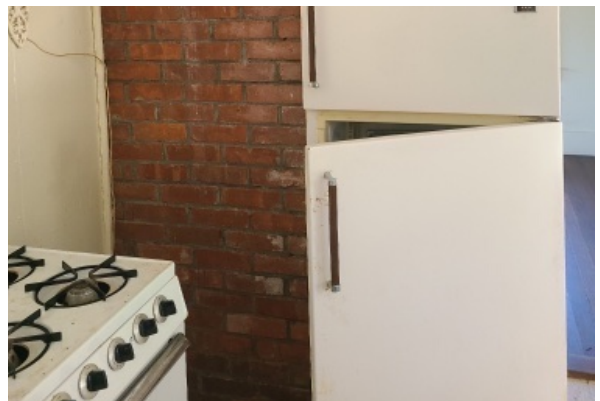
*Oven/stove fixture and refrigerator. Both require replacing due to age.*

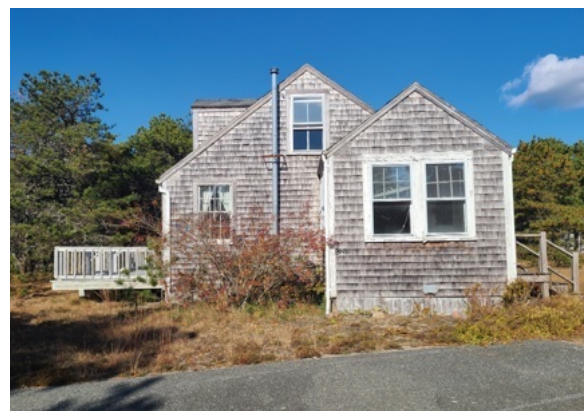
Unpainted cedar shingle siding in fair to poor conditons dependent upon wall orientation.

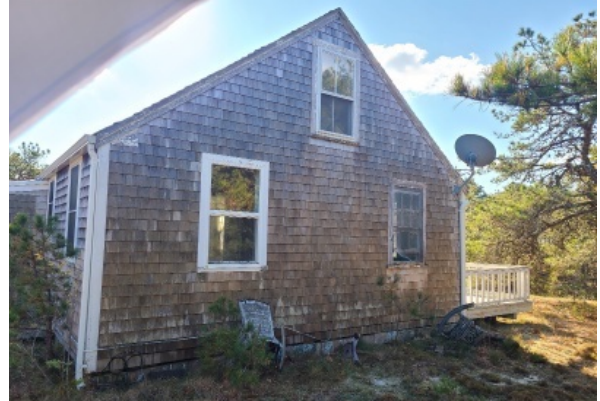
*North elevation shows staining indicating water damage at each window sill.*

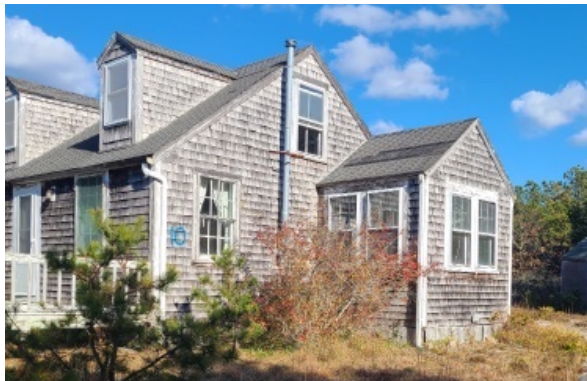
*Asphalt roof above kitchen addition shows insufficient roofing coverage.*

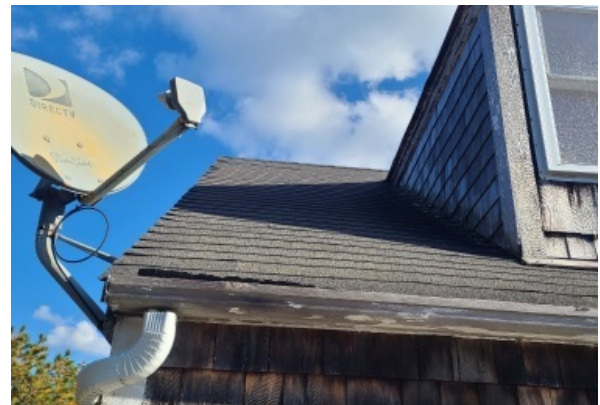
*Rotted Integral wood rain gutter and downspout are rusting and failing.*

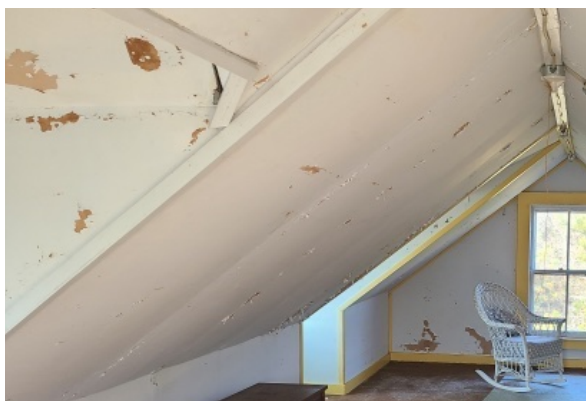
*Roof from the interior of the second level. Water damage can be seen, as well as ripples indicating further damage and settling.*

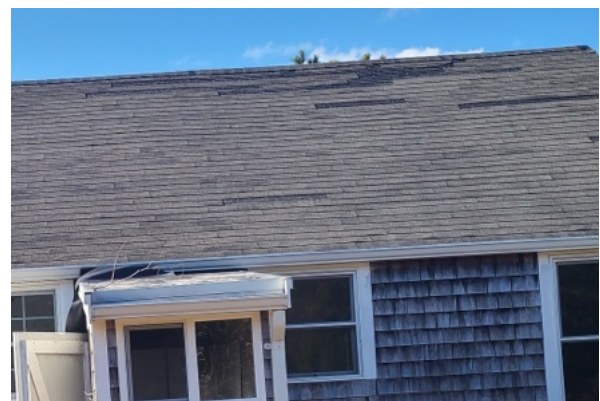
*Asphalt roof generally is failing, and the shower stall addition has failed at the connection to the main structure.*

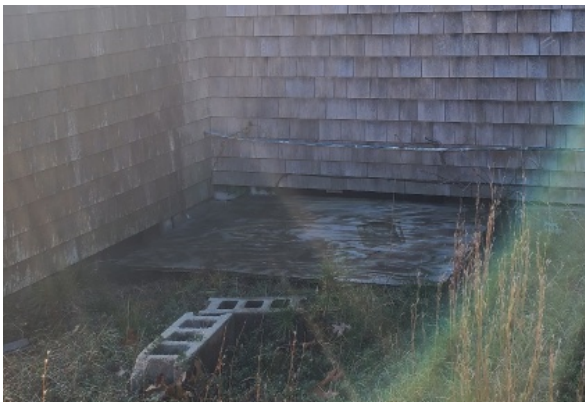
*Rotting wooden access hatch to foundation crawl space, and remnants of CMU retaining wall.*

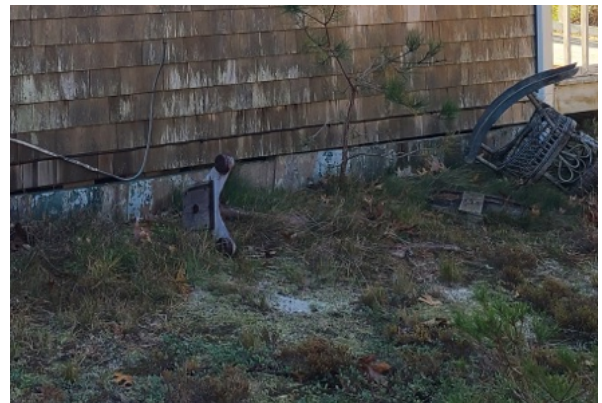
*Rotting wooden foundation enclosure at grade.*

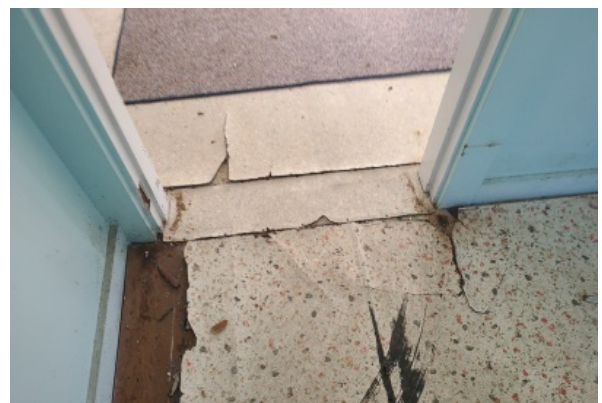
*Piece made sheet flooring crumbling at the edges. Multiple layers of flooring can be observed in the area at the top of this photo. The area at the bottom has large areas where the flooring has crumbled to reveal the floor sheathing.*

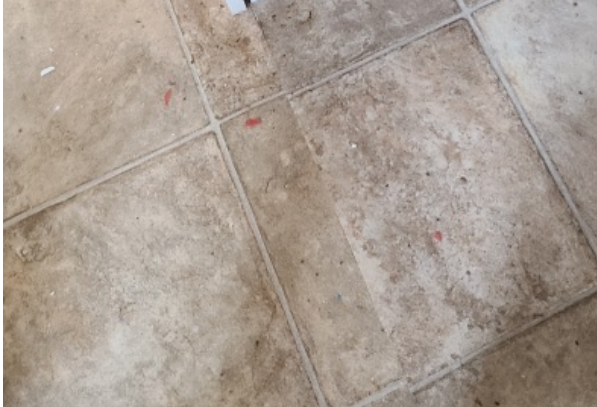
*Tile flooring with failing grout joints and cracked tiles.*

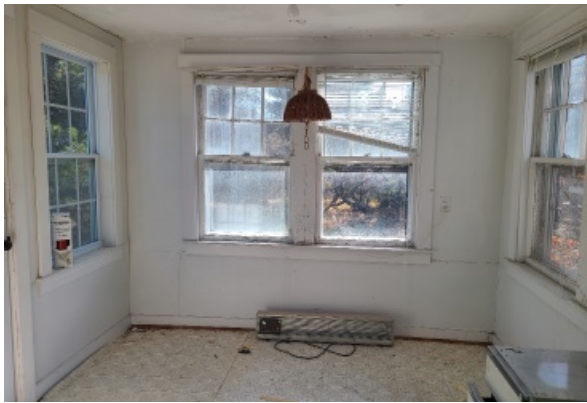
*Kitchen addition, paint is chipping and peeling throughout and water damage can be seen at the windows.*

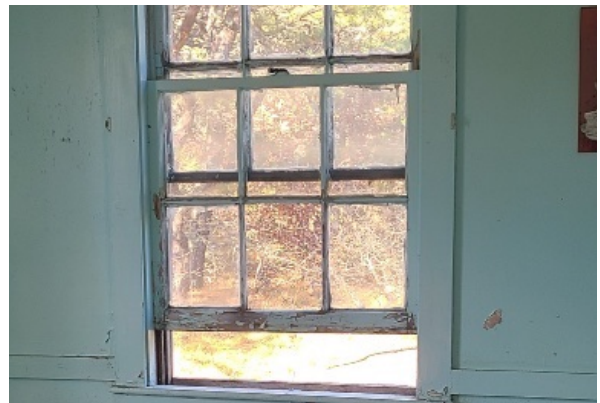
*This window stuck open, exposing the interior to the elements.*

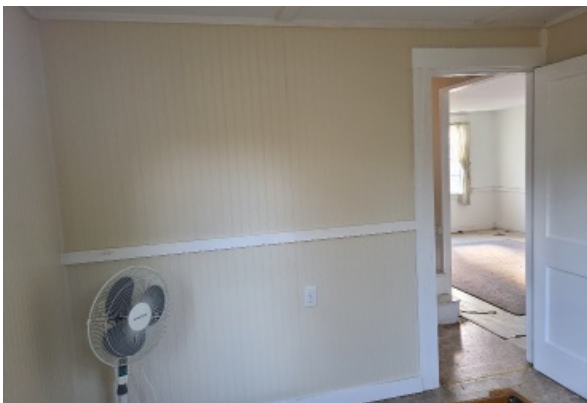
*Painted plaster wall with trim at base, mid, top, and about doorways. Paint is yellowing due to age.*

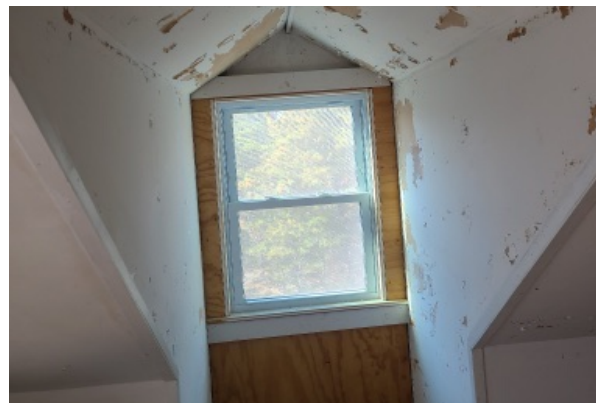
*Dormer condition at the second floor. Chipping paint and insufficient framing about window.*

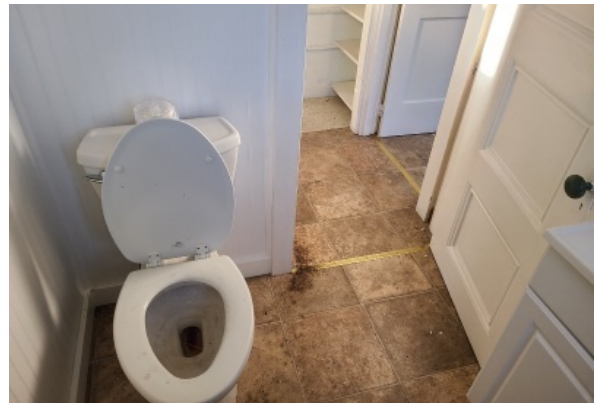
*Toilet fixture and sink, the layout of this bathroom is non-compliant with accessibility codes.*

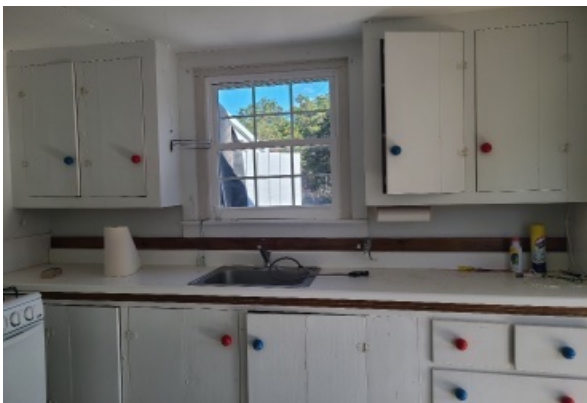
*In counter sink, with missing and non compliant hardware. Cabinet hardware is also non compliant.*

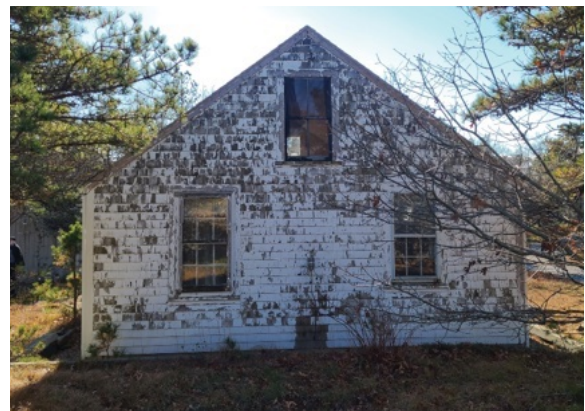
North elevation, cladding shows mold growth and paint has peeled from almost 50% of this face.

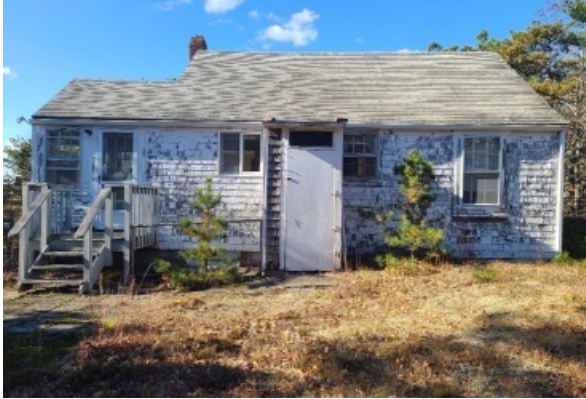
*View showing wooden steps into kitchen addition that are rotting due to age, and an exterior accessed shower stall attached to the back of the building.*

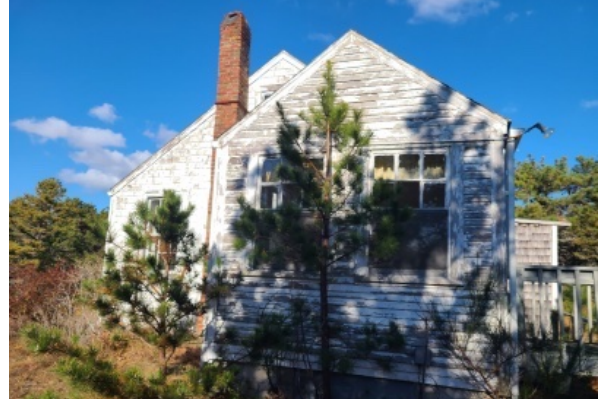
*Southern face of the building kitchen addition with newer windows than the rest, but still insufficient due to age.*

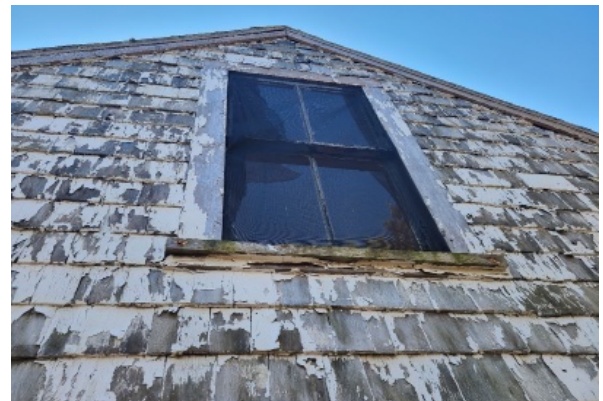
*North side peeling paint and rotted window sill. Window lacks storm.*

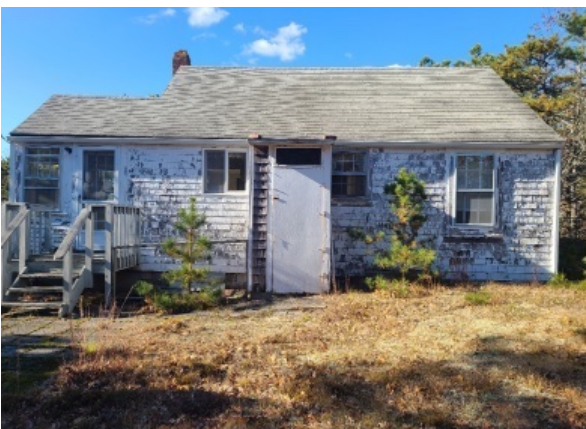
*Asphalt shingle roof is past it's useful lief. with small addition above shower stall. Bricks can be seen holding down the edges of the corners of the addition roof.*

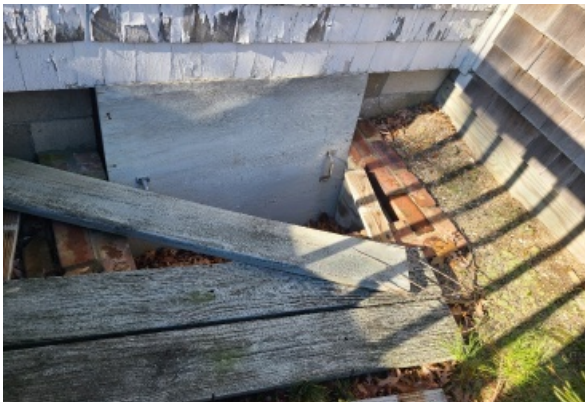
*Access panel a to crawl space*

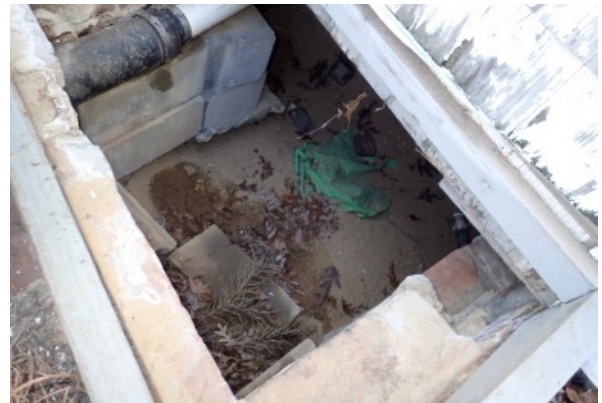
*Access to foundation crawl space, the foundation of CMU and wood members can be seen.*

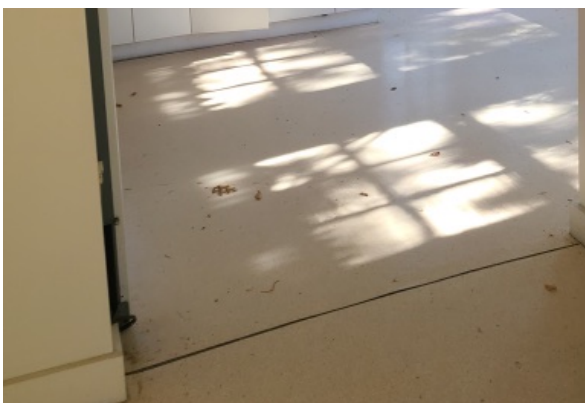
*Uneven flooring transition between two rooms.*

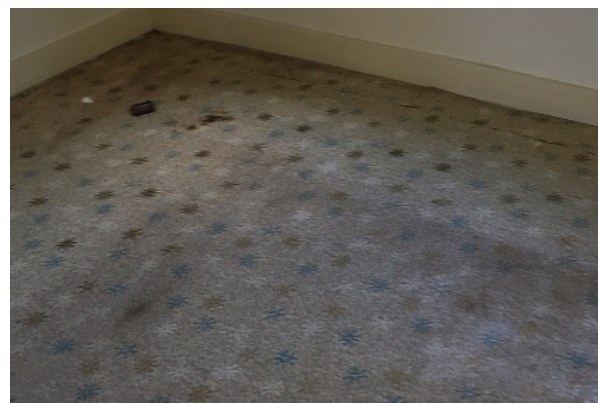
*Sheet flooring in bedroom, evidence of water damage, and is crumbling at the edges due to age.*

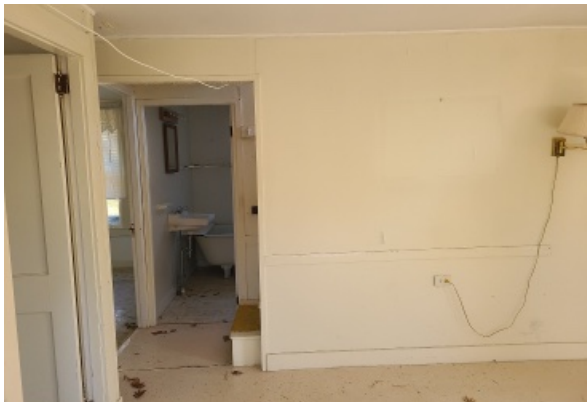
Painted plaster walls with crown molding. Paint is yellowing and peeling.

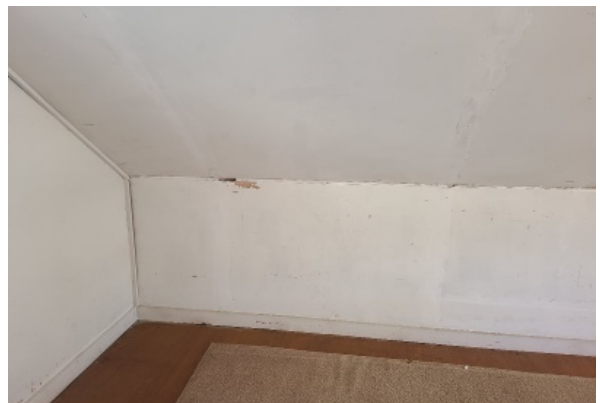
Variable wall heights at second level with trim board at borders, paint is chipping and peeling throughout.

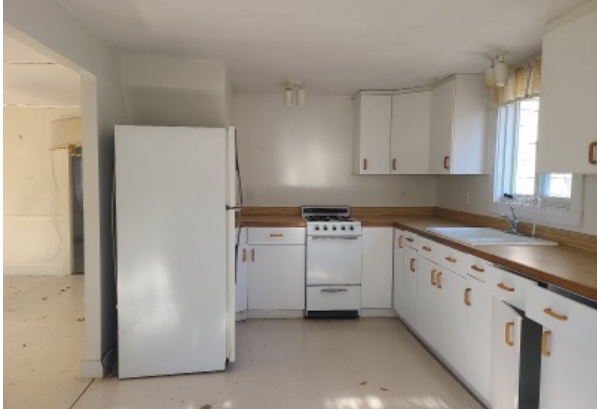
*View of kitchen including stove/oven fixture, refrigerator, and in counter double sink. The stove/oven and refrigerator are outdated.*

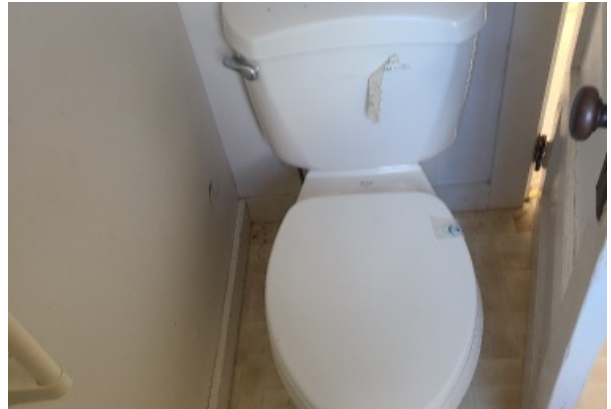
*Toilet fixture in non compliant location.*

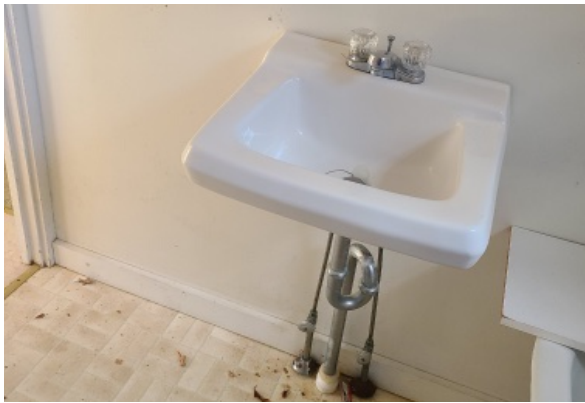
*Sink fixture with non compliant hardware and uninsulated non-compliant piping below.*

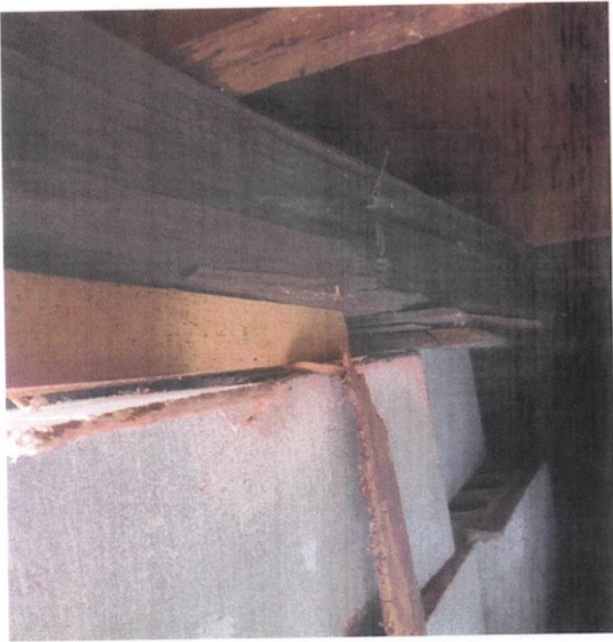
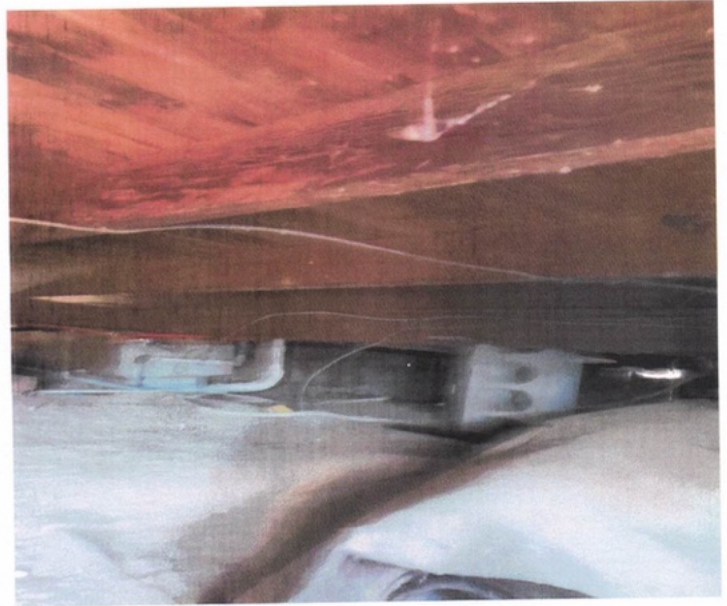
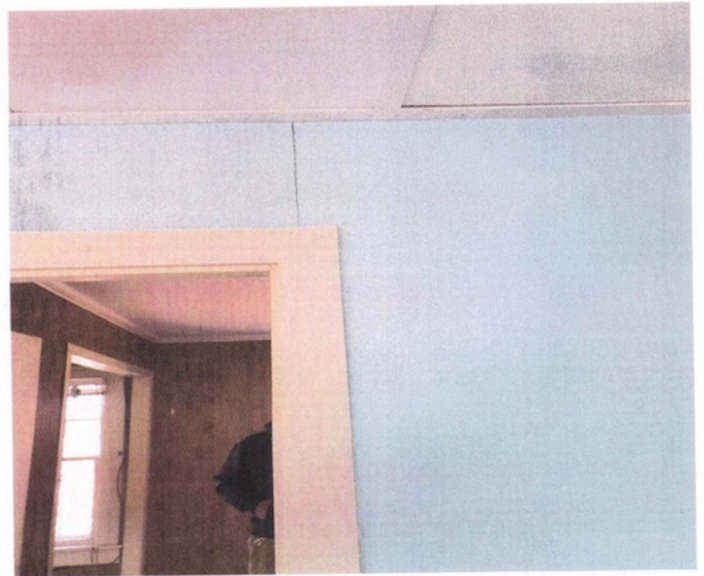
The superstructure core, the Sears portion, may be considered for reuse, however, the presence of cracks in the architectural finish indicates gaps in the framing that need to be re-fastened. Roof leaks need to be sealed and damaged wood requires replacement. All architectural finish requires replacement due to mold remediation.

Alternatively, demolition and reconstruction is suggested.

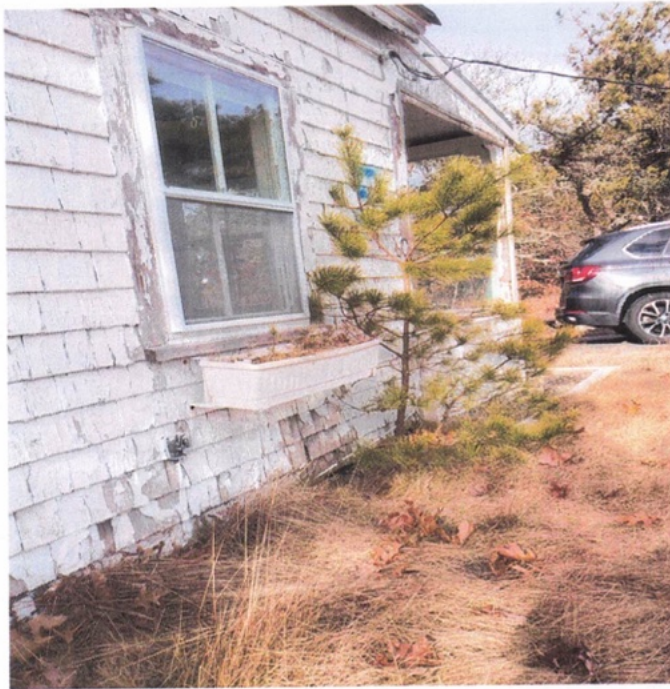
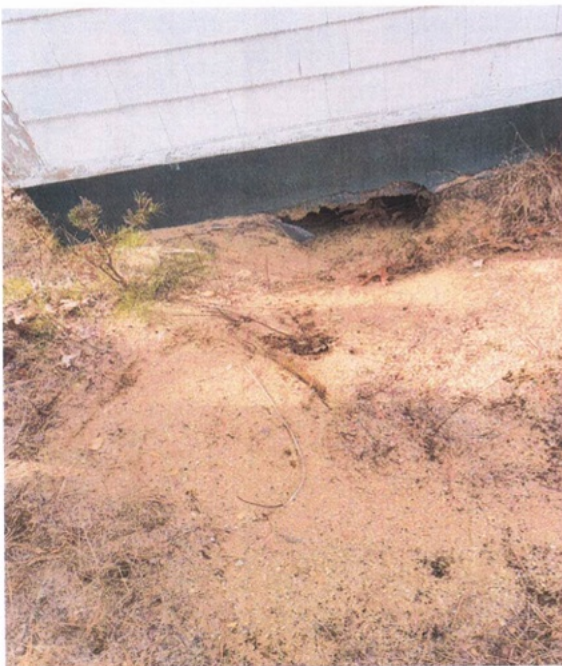
**The superstructure core, the Sears portion, may be considered for reuse; however, the presence of cracks in the architectural finish indicates gaps in the framing that need to be re-fastened. Roof leaks need to be sealed and damaged wood requires replacement. All architectural finish requires replacement due to mold remediation.**

Alternatively, demolition and reconstruction is suggested.

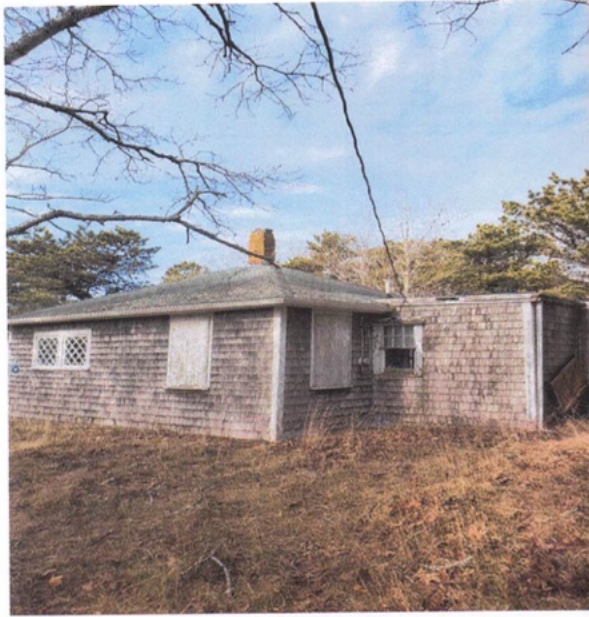
The superstructure core, the Sears portion, may be considered for reuse; however, the presence of cracks in the architectural finish indicates gaps in the framing that need to be re-fastened. Roof leaks need to be sealed and damaged wood requires replacement. All architectural finish requires replacement due to mold remediation.

Alternatively, demolition and reconstruction is suggested.
